*ONTARIO INTERNATIONAL
AIRPORT
ONTARIO, CA*

*PAVEMENT MANAGEMENT
PROGRAM (PMP) REPORT:
AIRSIDE*

MARCH 2020

RS&H No.:
226-0047-000

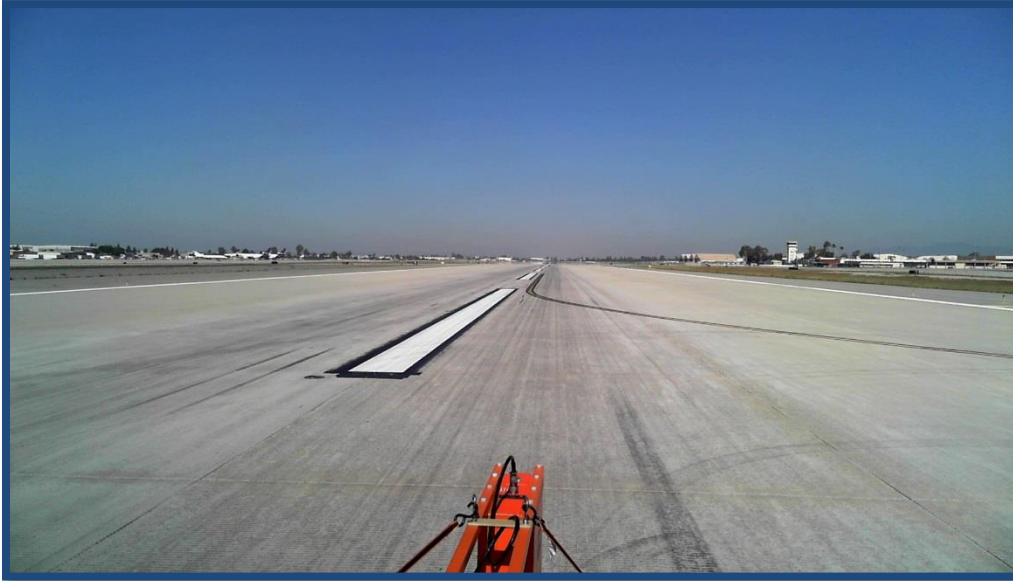
Figure F.1. Runway 8L-26R Representative Pavement Condition (Sta. 59+75)

From Sta. 0+00 to Sta. 120+25, the PCC pavement surface appears to be in good condition with no distresses noted. Rubber build-up was noted from approximately Sta. 5+50 to Sta. 43+00 and from approximately Sta. 76+00 to Sta. 104+00, which may be concealing distresses.

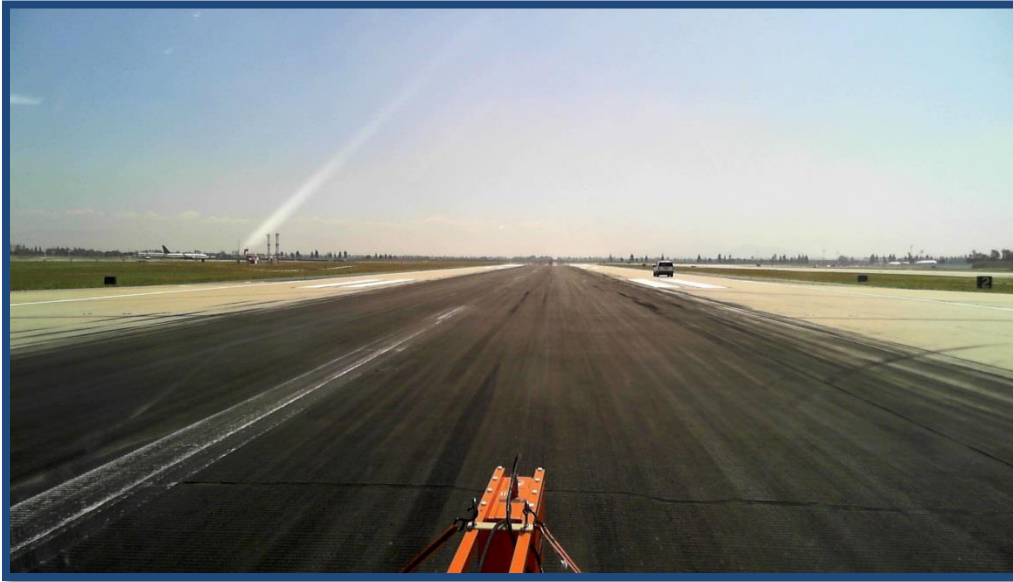
Figure F.2. Runway 8R-26L Representative Pavement Condition (Sta. 23+00)

From Sta. 0+00 to Sta. 100+50, the PCC pavement surface appears to be in fairly good condition with a localized sealed corner crack noted at Sta. 17+25, 18+75, and 19+75; and sealed transverse crack noted at Sta. 23+00; and sealed longitudinal crack noted at Sta. 91+25. Rubber build-up was noted from approximately Sta. 5+50 to Sta. 58+00, which may be concealing distresses.

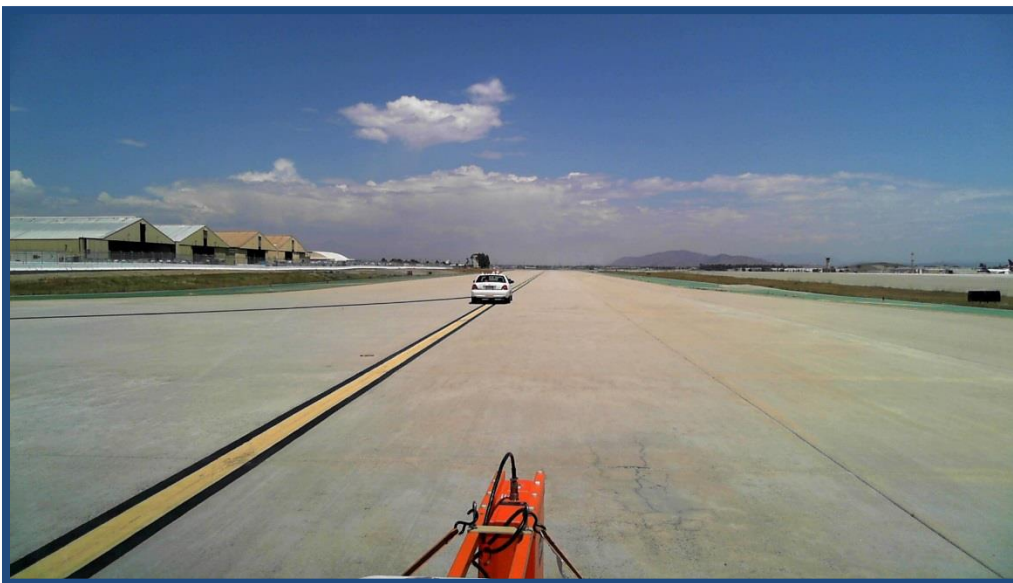
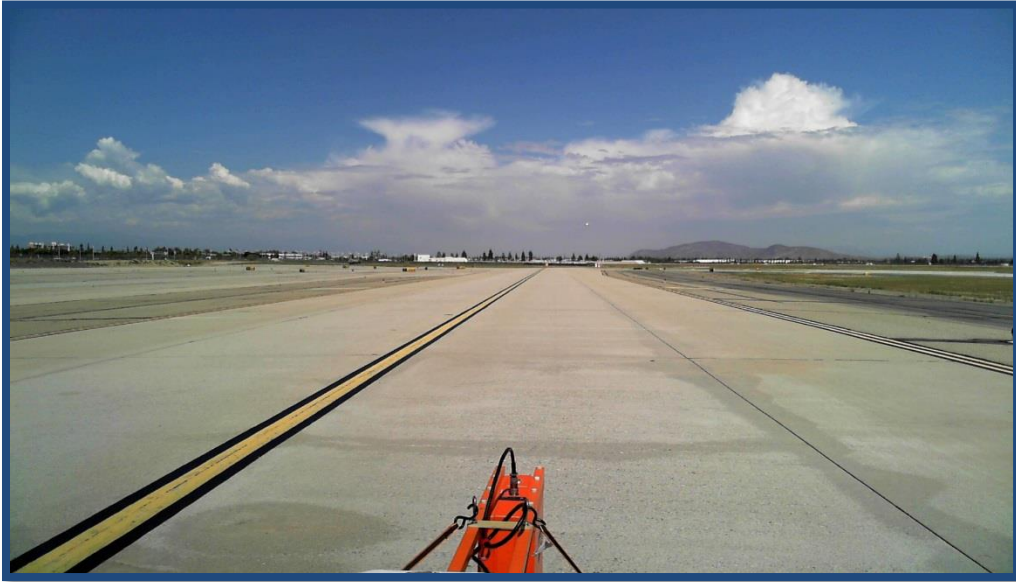
From Sta. 0+00 to Sta. 105+50, the PCC pavement surface appears to be in fairly good condition with a localized longitudinal crack noted at approximately Sta. 1+25. A pavement change was noted at approximately Sta. 45+00. From Sta. 105+50 to Sta. 120+00, the PCC pavement surface appears to be in fairly poor condition with localized transverse and longitudinal cracks noted.

Figure F.3. Taxiway N Representative Pavement Condition (Sta. 1+25)

Figure F.4. Taxiway N Representative Pavement Condition (Sta. 110+00)

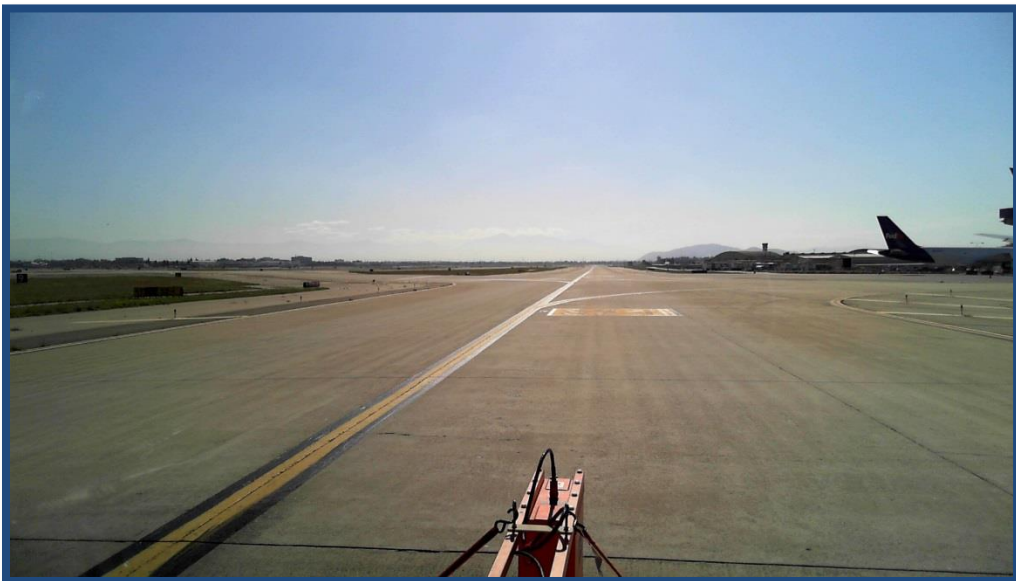
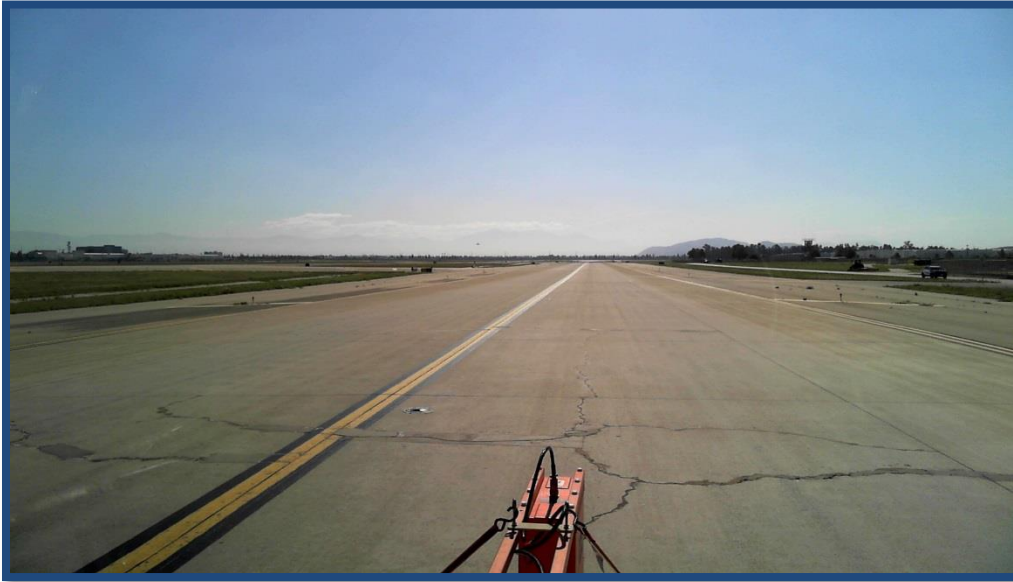
From Sta. 0+00 to Sta. 41+00, the PCC pavement surface appears to be in fairly good condition with a localized transverse crack noted at approximately Sta. 6+00. From Sta. 41+00 to Sta. 98+75, the PCC pavement surface to the right of the centerline appears to be in fairly poor condition with longitudinal and transverse cracks noted. The pavement surface to the left of the centerline appears to be in slightly better condition with localized longitudinal and transverse cracks noted.

Figure F.5. Taxiway S Representative Pavement Condition (Sta. 6+00)

Figure F.6. Taxiway S Representative Pavement Condition (Sta. 46+75)

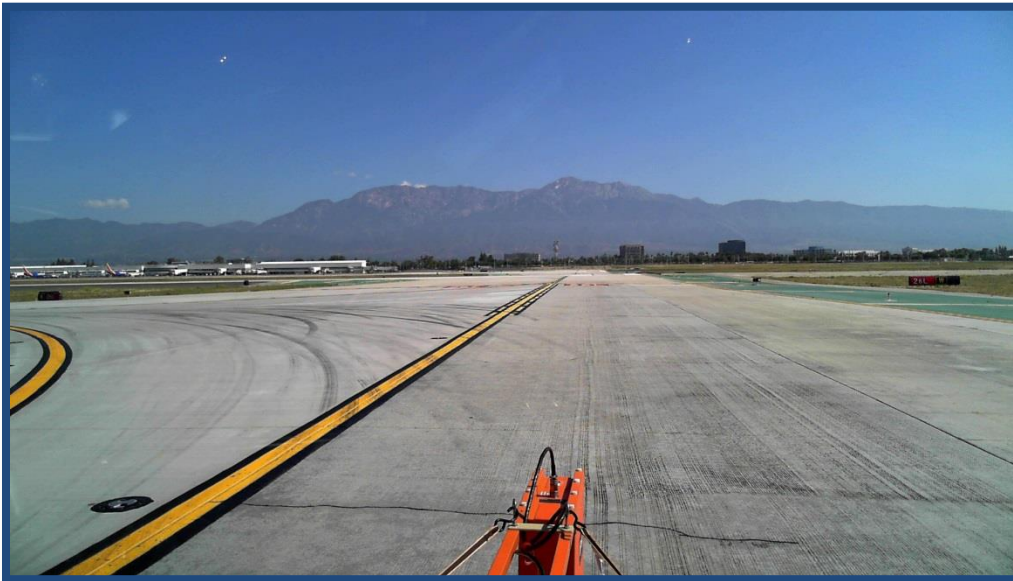
Figure F.7. Taxiway W Representative Pavement Condition (Sta. 1+25)

From Sta. 0+00 to Sta. 3+15, the PCC pavement surface appears to be in fairly good condition with a localized sealed transverse crack noted at approximately Sta. 1+25.

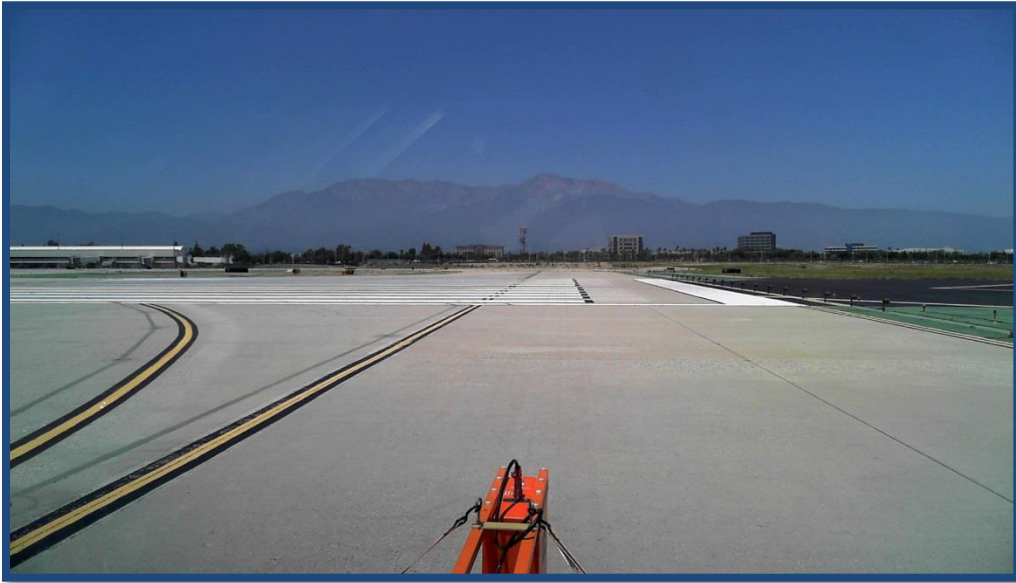
Figure F.8. Taxiway W Representative Pavement Condition (Sta. 1+50)

From Sta. 0+00 to Sta. 11+00, the PCC pavement surface appears to be in fairly good condition with localized transverse cracks noted.

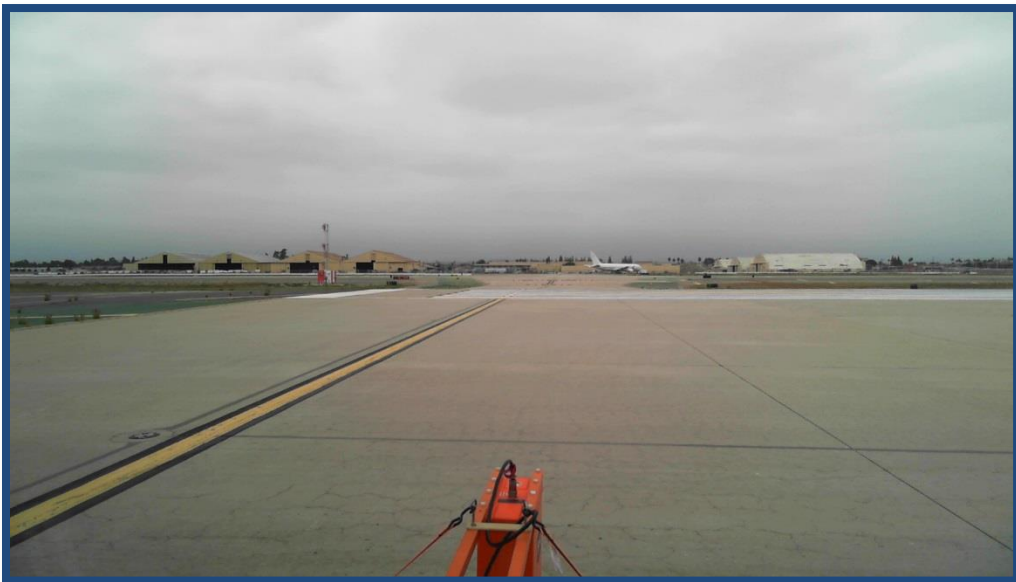
Figure F.9. Taxiway D Representative Pavement Condition (Sta. 2+00)

From Sta. 0+00 to Sta. 7+35, the PCC pavement surface appears to be in fairly good condition with localized transverse and map cracking noted.

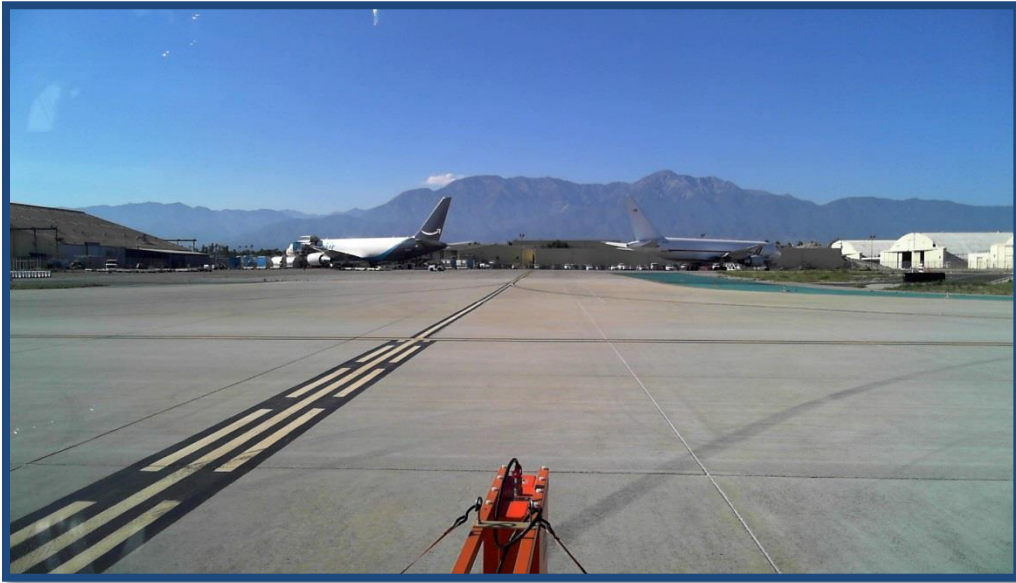
Figure F.10. Taxiway D Representative Pavement Condition (Sta. 7+01)

From Sta. 0+00 to Sta. 9+50, the PCC pavement surface appears to be in fairly good condition with no noticeable distresses.

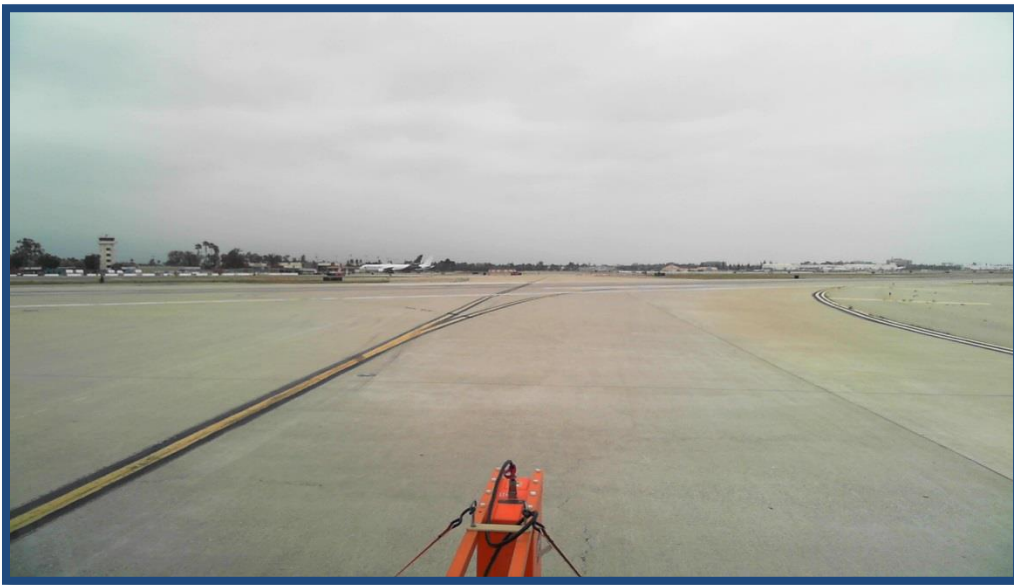
Figure F.11. Taxiway F Representative Pavement Condition (Sta. 2+00)

From Sta. 0+00 to Sta. 9+90, the PCC pavement surface appears to be in fairly good condition with longitudinal and transverse cracks noted.

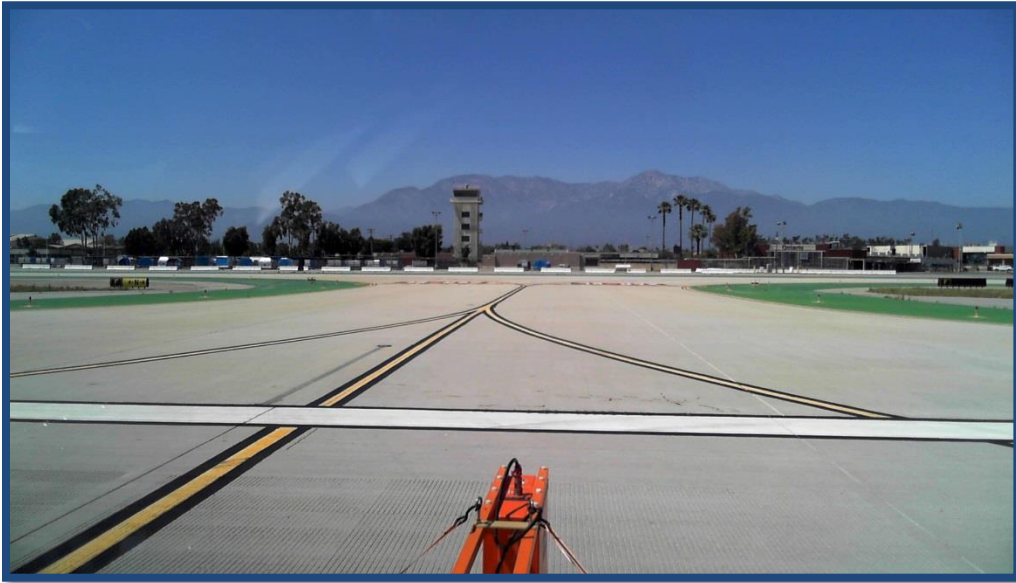
Figure F.12. Taxiway F Representative Pavement Condition (Sta. 3+75)

From Sta. 0+00 to Sta. 7+00, the PCC pavement surface appears to be in fairly good condition with localized transverse cracks noted at approximately Sta. 3+75.

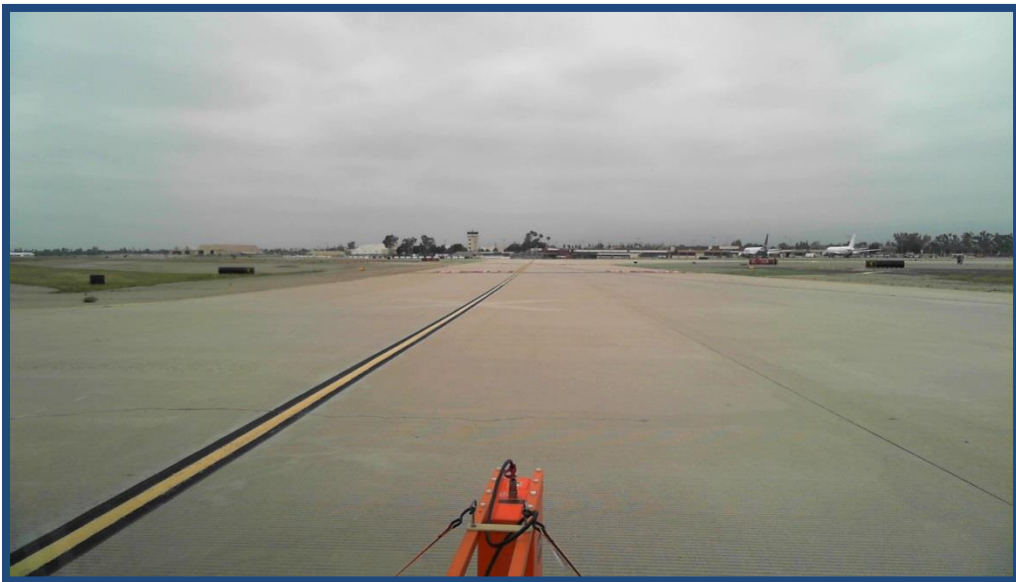
Figure F.13. Taxiway K Representative Pavement Condition (Sta. 5+75)

From Sta. 0+00 to Sta. 10+00, the PCC pavement surface appears to be in fairly good condition with transverse cracks noted.

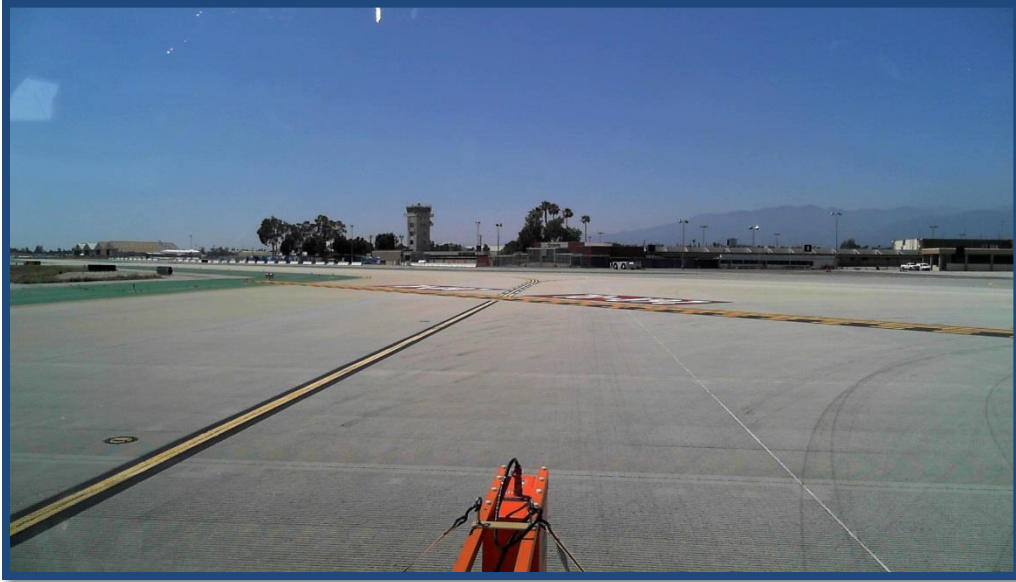
Figure F.14. Taxiway K Representative Pavement Condition (Sta. 7+99)

From Sta. 0+00 to Sta. 10+20, the PCC pavement surface appears to be in good condition with no noticeable distresses.

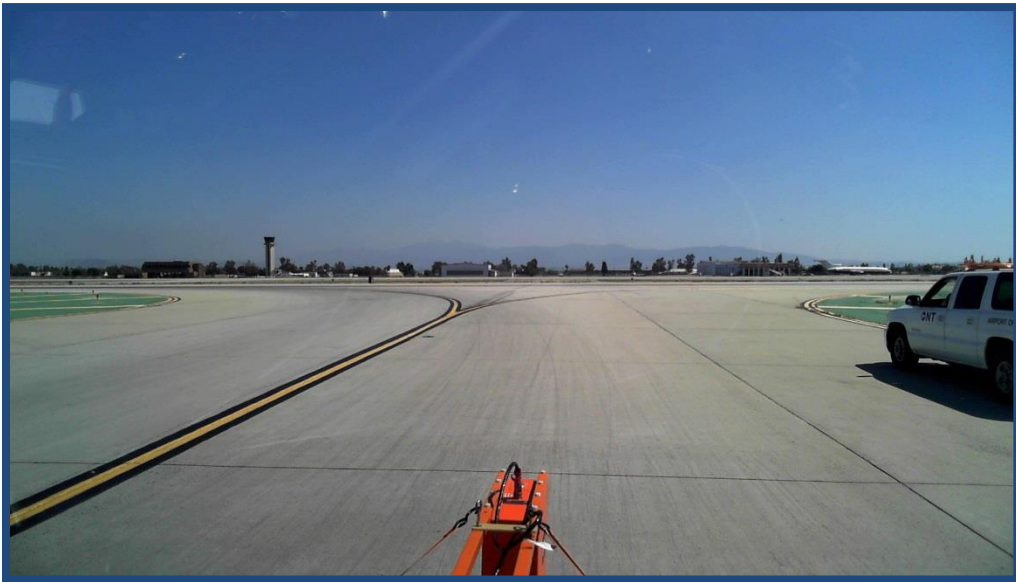
Figure F.15. Taxiway L Representative Pavement Condition (Sta. 2+25)

From Sta. 0+00 to Sta. 3+00, the PCC pavement surface appears to be in fairly good condition with no noticeable cracks.

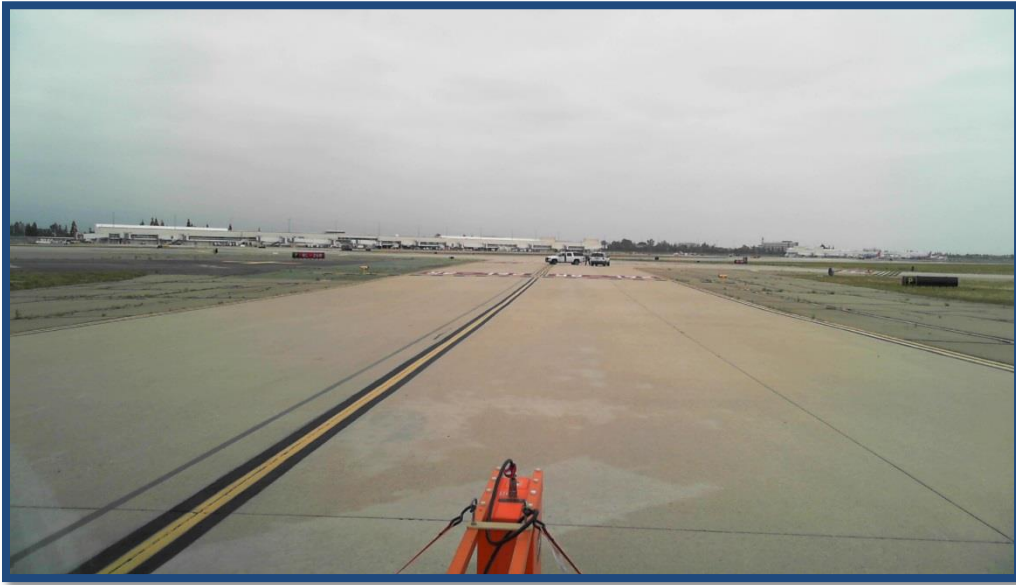
Figure F.16. Taxiway P Representative Pavement Condition (Sta. 6+50)

From Sta. 0+00 to Sta. 10+10, the PCC pavement surface appears to be in good condition with no noticeable distresses.

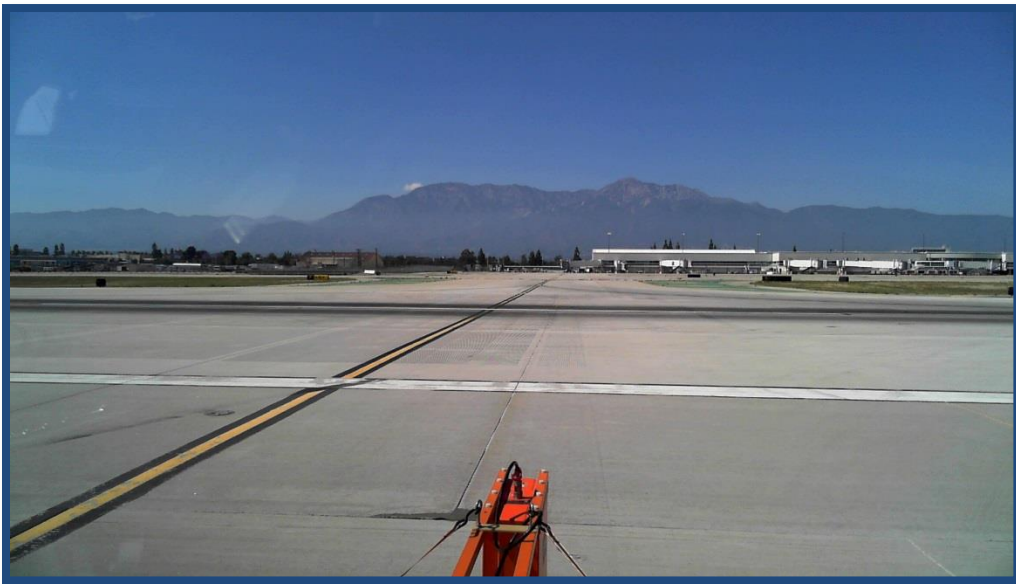
Figure F.17. Taxiway P Representative Pavement Condition (Sta. 1+98)

From Sta. 0+00 to Sta. 10+45, the PCC pavement surface appears to be in good condition with a localized patch noted at approximately Sta. 1+98.

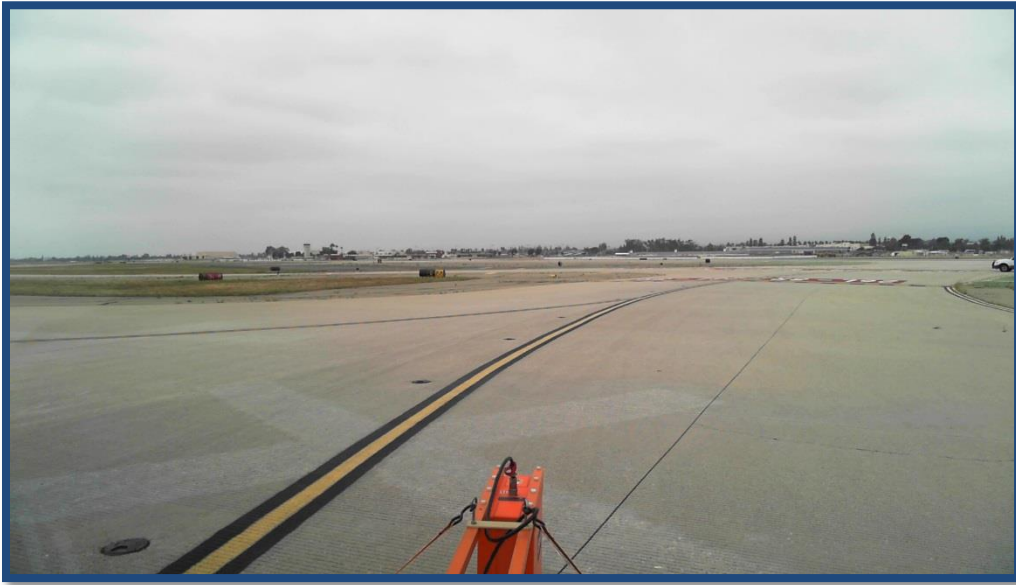
Figure F.18. Taxiway Q Representative Pavement Condition (Sta. 6+30)

From Sta. 0+00 to Sta. 9+50, the PCC pavement surface appears to be in fairly good condition with a localized transverse crack noted.

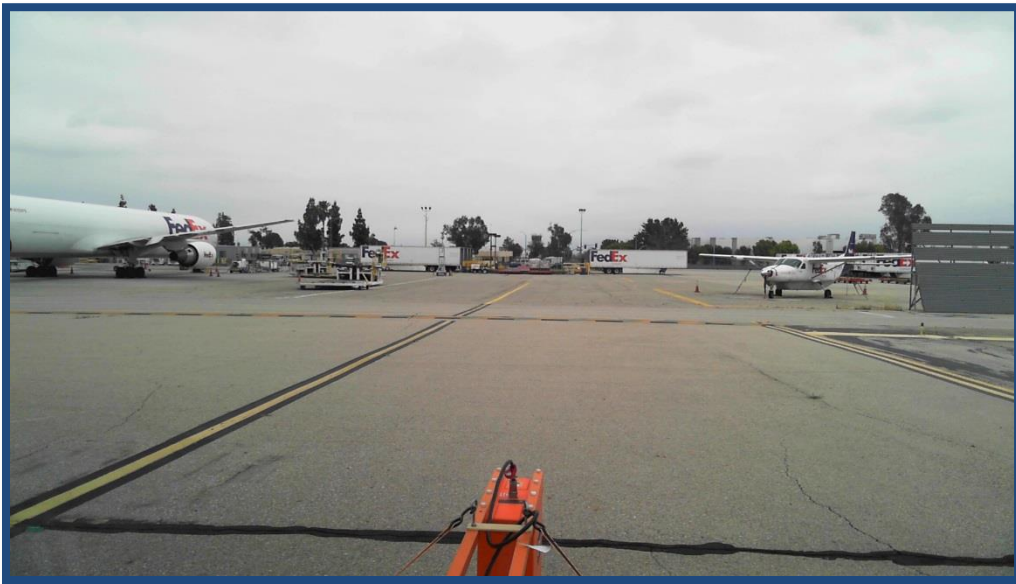
Figure F.19. Taxiway S1 Representative Pavement Condition (Sta. 0+00)

From Sta. 0+00 to Sta. 1+00, the AC pavement surface appears to be in fairly poor condition with longitudinal and transverse cracks noted.

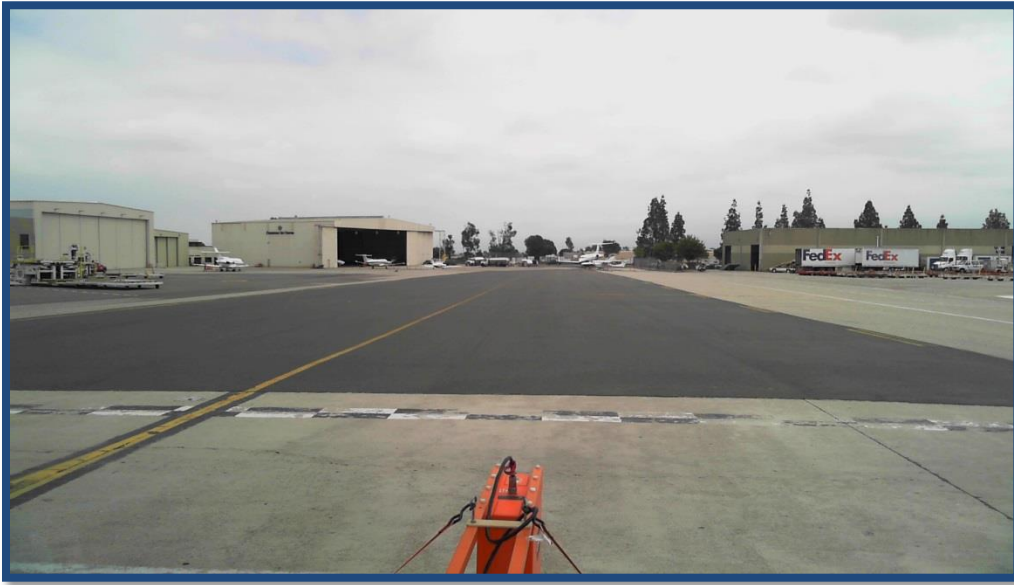
Figure F.20. Taxiway S2 Representative Pavement Condition (Sta. 1+05)

From Sta. 0+00 to Sta. 1+45, the PCC pavement surface appears to be in fairly good condition with a localized transverse crack noted at Sta. 1+05.

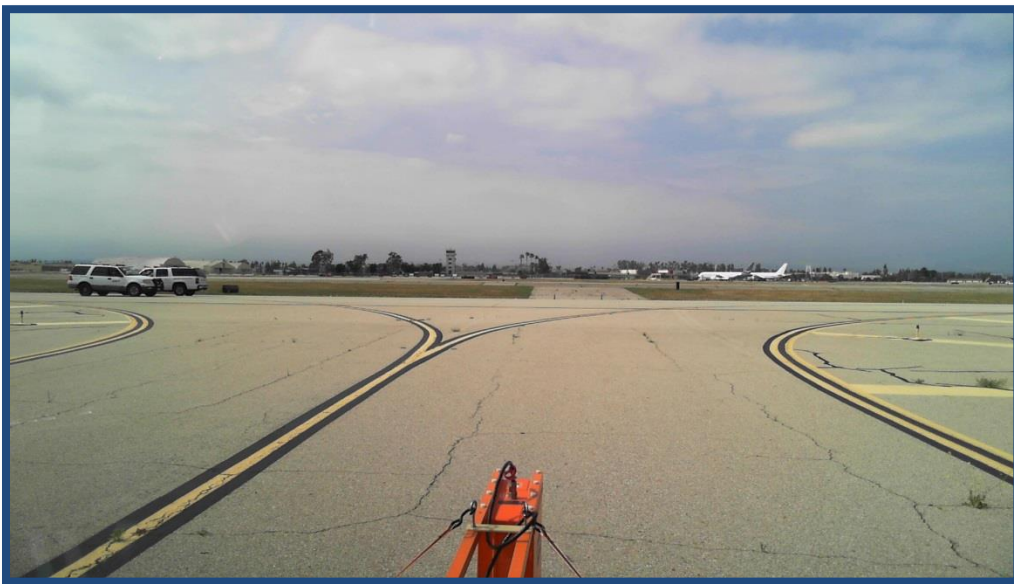
Figure F.21. Taxiway S3 Representative Pavement Condition (Sta. 1+25)

From Sta. 0+00 to Sta. 1+45, the AC pavement surface appears to be in fairly poor condition with block cracks noted.

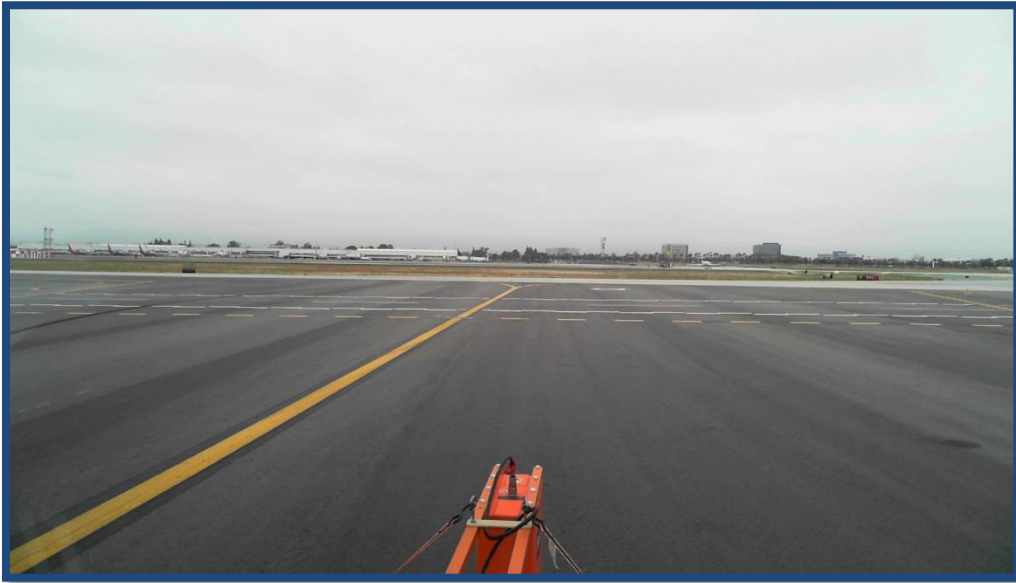
Figure F.22. Taxiway S5 Representative Pavement Condition (Sta. 5+00)

From Sta. 0+00 to Sta. 8+00, the AC pavement surface appears to be in fairly good condition with no noticeable cracks.

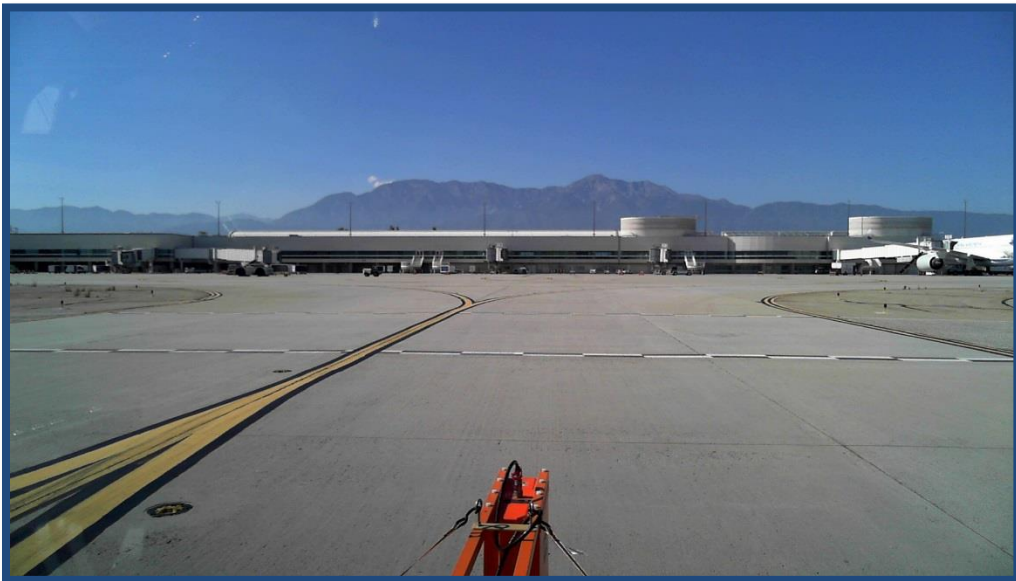
Figure F.23. Taxiway R Representative Pavement Condition (Sta. 5+48)

From Sta. 0+00 to Sta. 3+00, the PCC pavement surface appears to be in fairly good condition with no noticeable cracks.

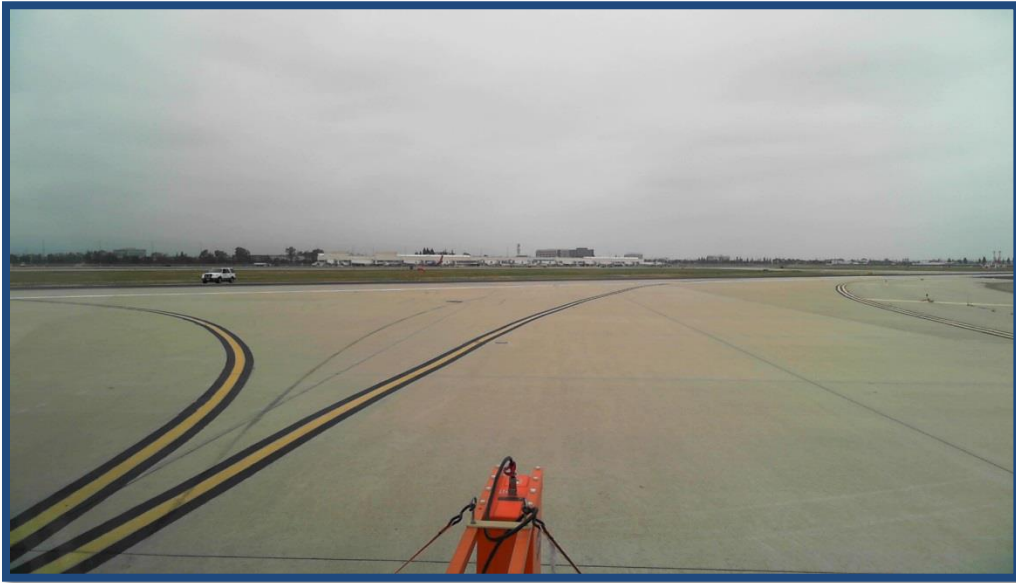
Figure F.24. Taxiway T Representative Pavement Condition (Sta. 1+50)

From Sta. 0+00 to Sta. 4+40, the PCC pavement surface appears to be in fairly good condition with no noticeable cracks.

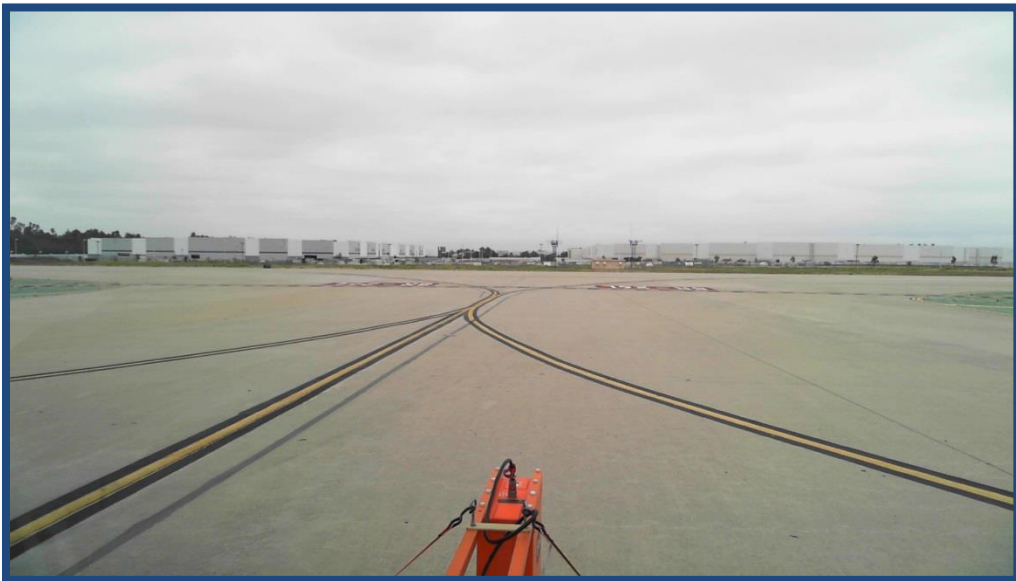
Figure F.25. Taxiway U Representative Pavement Condition (Sta. 2+75)

From Sta. 0+00 to Sta. 6+50, the PCC pavement surface appears to be in fairly good condition with transverse cracks noted at approximately Sta. 2+75 and 4+75 of the left side of the centerline.

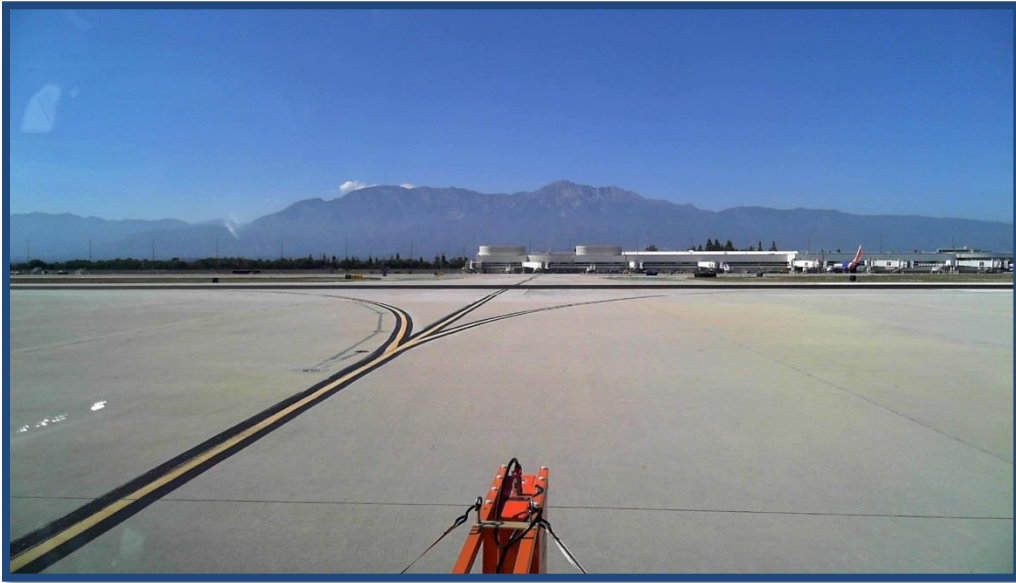
Figure F.26. Taxiway U Representative Pavement Condition (Sta. 1+25)

From Sta. 0+00 to Sta. 10+90, the PCC pavement surface appears to be in fairly good condition with no noticeable cracks.

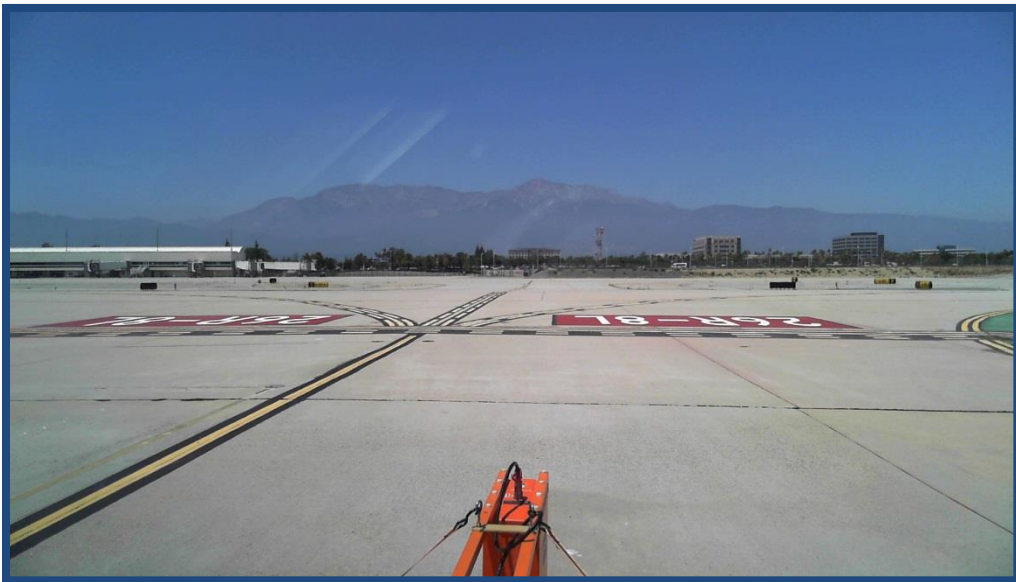
Figure F.27. Taxiway V Representative Pavement Condition (Sta. 1+00)

From Sta. 0+00 to Sta. 6+40, the PCC pavement surface appears to be in fairly good condition with no noticeable cracks.
