*ONTARIO INTERNATIONAL
AIRPORT
ONTARIO, CA*

*PAVEMENT MANAGEMENT
PROGRAM (PMP) REPORT:
AIRSIDE*

MARCH 2020

RS&H No.:
226-0047-000

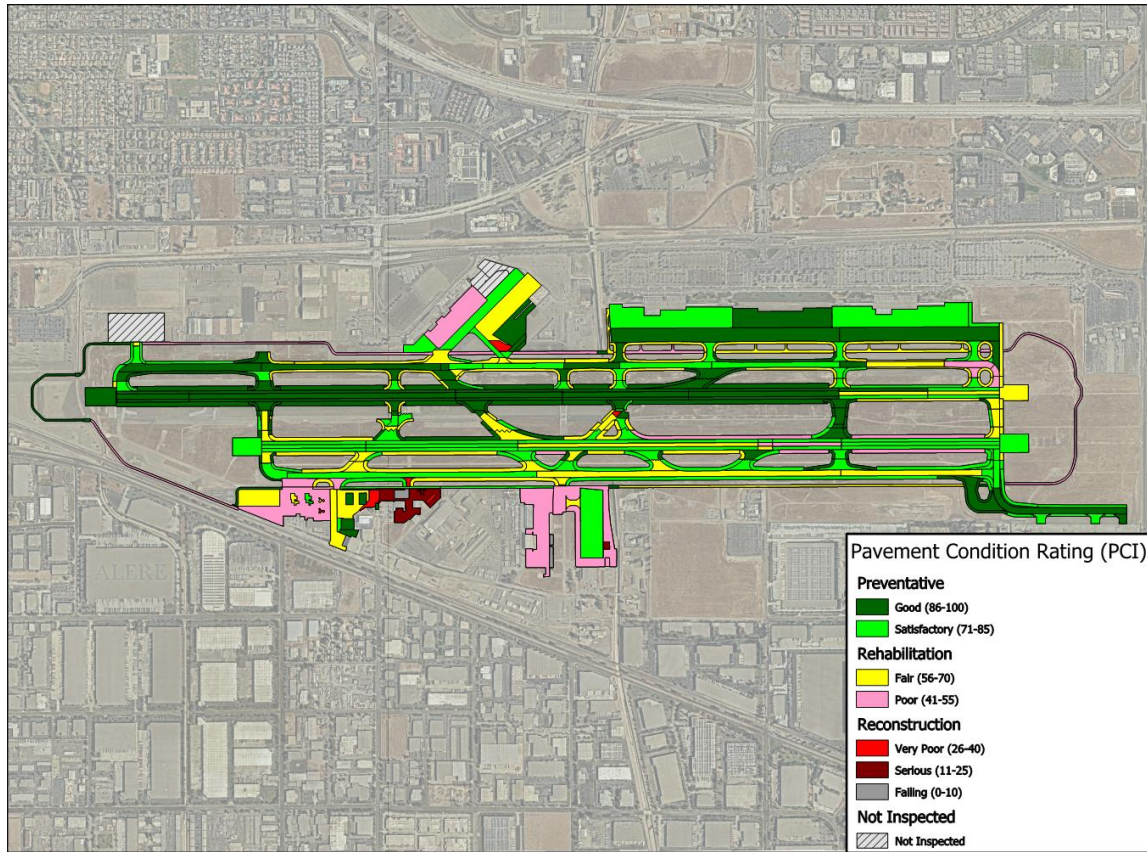
FIGURE 1-1: AIRSIDE PAVEMENT PCI

The pavement inspection scope was to perform 100% inspection on all airfield pavements except areas that were under construction, in the process of being demolished, closed portions of the airfield, outside of existing shoulders that do not serve any structural use, or that are being maintained by other entities. All pavement distresses were documented and processed, resulting in PCI values assigned to each pavement section as shown on **Figure 1-1**. The maintenance classification (i.e. Preventative, Rehabilitation, Reconstruction) as shown on **Figure 1-1** is a simple way to categorize the maintenance needs of each pavement section based on the PCI value and corresponding pavement condition rating. The figure below is also shown in Chapter 4.

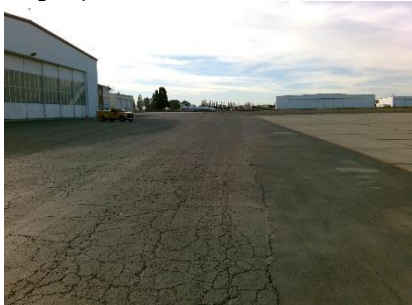
Distress Code	Description	Distress Type	Severity Levels	Sample Pictures
41	Alligator or Fatigue Cracking	Load	<p><u>Low</u> Fine, longitudinal hairline cracks running parallel to each other with no or only a few interconnecting cracks. The cracks are not spalled. Buckling or shattering causes low-severity ride quality.</p> <p><u>Medium</u> Further development of light alligator cracking into a pattern or network of cracks that may be lightly spalled. Buckling or shattering causes medium-severity ride quality.</p> <p><u>High</u> Network or pattern cracking progressed so that pieces are well-defined and spalled at the edges; some of the pieces rock under traffic.</p>	<p><u>High</u> Severity Alligator Cracking at South Cargo Apron</p>

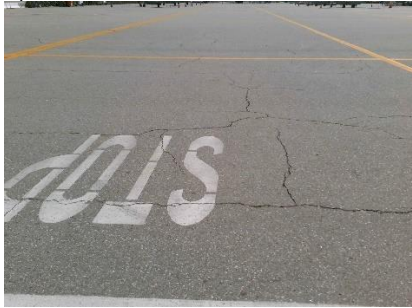
43	Block Cracking	Climate	<p><u>Low</u> Blocks are defined by cracks that are non-spalled (sides of the crack are vertical) or only lightly spalled, causing no FOD potential. Non-filled cracks have 1/4 inch or less mean width, and filled cracks have filler in satisfactory condition.</p> <p><u>Medium</u> Blocks are defined by either: (1) filled or non-filled cracks that are moderately spalled (some FOD potential); (2) non-filled cracks that are not spalled or have only minor spalling (some FOD potential), but have a mean width greater than approximately 1/4 inch; or (3) filled cracks that are not spalled or have only minor spalling (some FOD potential), but have filler in unsatisfactory condition.</p> <p><u>High</u> Blocks are well-defined by cracks that are severely spalled with loose or missing material, causing a definite FOD potential.</p>	<p><u>Low</u> Severity Block Cracking at FedEx Apron</p>

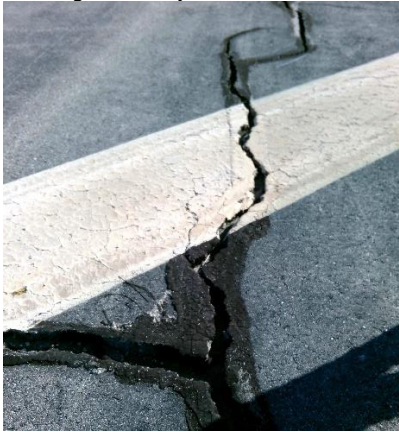
Distress Code	Description	Distress Type	Severity Levels	Sample Pictures
			<p>crack width is greater than 1/4 inch; or (4) light random cracking exists near the crack or at the corner of intersecting cracks.</p> <p><u>High</u> Cracks are severely spalled (definite FOD potential) and can be either filled or non-filled of any width.</p>	
48	Longitudinal and Transverse Cracking	Climate/ Other	<p><u>Low</u> Cracks have either minor spalling (little or no FOD potential) or no spalling. The cracks can be filled or non-filled. Non-filled cracks have a mean width of 1/4 inch or less; filled cracks are of any width, but their filler material is in satisfactory condition.</p> <p><u>Medium</u> One of the following conditions exists: (1) cracks are moderately spalled (some FOD potential) and can be either filled or non-filled of any width; (2) filled cracks are not spalled or are only lightly spalled, but the filler is in unsatisfactory condition; (3) non-filled cracks are not spalled or are only lightly spalled, but mean crack width is greater than 1/4 inch; or (4) lightly random cracking exists near the crack or at the corners of intersecting cracks..</p> <p><u>High</u> Cracks are severely spalled, causing definite FOD potential. They can be either filled or non-filled of any width.</p>	<p><u>Medium</u> Longitudinal and Transverse Cracking at Runway 8R Blast Pad</p>

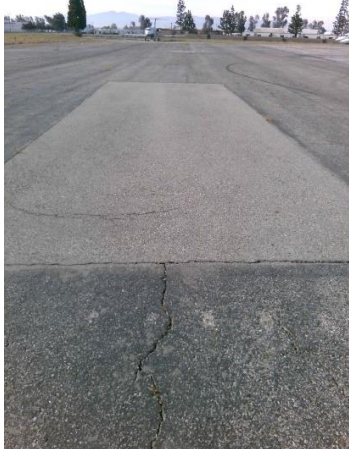
Distress Code	Description	Distress Type	Severity Levels	Sample Pictures
50	Patching and Utility Cut Patch	Other	<p><u>Low</u> Patch is in good condition and is performing satisfactorily. Little or no FOD potential.</p> <p><u>Medium</u> Patch is somewhat deteriorated and affects riding quality to some extent. Some FOD potential.</p> <p><u>High</u> Patch is badly deteriorated and affects riding quality significantly or has high FOD potential. Patch needs replacement.</p>	<p><u>Low</u> Severity Patching at Atlantic Aviation Apron</p>

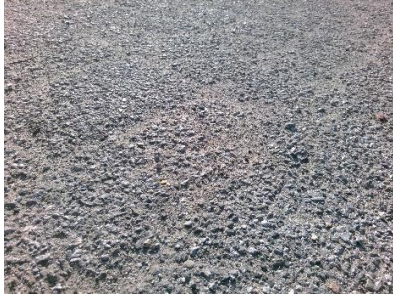
Distress Code	Description	Distress Type	Severity Levels	Sample Pictures
			<p><u>High</u> Swell can be readily observed and severely affects the pavement's ride quality at the normal aircraft speed for the pavement section under consideration.</p>	
57	Weathering	Load/Climate/Other	<p><u>Low</u> Asphalt surface beginning to show signs of aging which may be accelerated by climatic conditions. Loss is the fine aggregate matrix is noticeable and may be accompanied by fading of the asphalt color. Edges of the coarse aggregates are beginning to be exposed. Pavement may be relatively new (as new as 6 months old).</p> <p><u>Medium</u> Loss of fine aggregate matrix is noticeable and edges of coarse aggregate have been exposed up to 1/4 width (of the longest side) of the coarse aggregate due to the loss of fine aggregate matrix.</p> <p><u>High</u> Edges of coarse aggregate have been exposed greater than 1/4 width (of the longest side) of the coarse aggregate. There is considerable loss of fine aggregate matrix leading to potential or some loss of coarse aggregate.</p>	<p>Hight Severity Weathering at FedEx Apron</p>

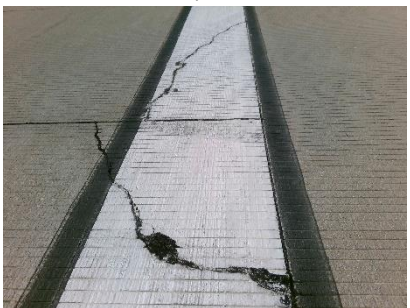
62	Corner Break	Load	<p><u>Low</u> Crack has either no spalling or minor spalling (no foreign object damage (FOD) potential). If non-filled, it has a mean width less than approximately 1/8 inch; a filled crack can be of any width, but the filler material must be in satisfactory condition. The area between the corner break and the joints is not cracked.</p> <p><u>Medium</u> One of the following conditions exists: (1) filled or non-filled crack is moderately spalled (some FOD potential); (2) a non-filled crack has a mean width between 1/8 inch and 1 inch; (3) a filled crack is not spalled or only lightly spalled, but the filled is in unsatisfactory condition; (4) the area between the corner break and the joints is lightly cracked with loose or missing particles.</p> <p><u>High</u> One of the following conditions exists: (1) filled or non-filled crack is severely spalled, causing definite FOD potential; (2) a non-filled crack has a mean width greater than approximately 1 inch, creating a tire damage potential; or (3) the area between the corner break and the joints is severely cracked.</p>	<p><u>Low</u> Severity Corner Break at Runway 8R/26L</p>

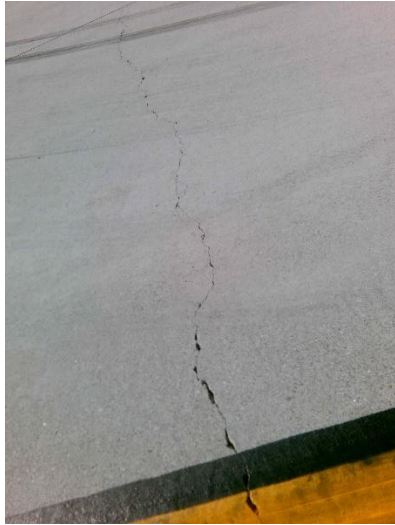
Distress Code	Description	Distress Type	Severity Levels	Sample Pictures
63	Long., Trans., or Diagonal Crack	Load	<p><u>Low</u> Crack has no spalling or minor spalling (no FOD potential). If non-filled, it is less than 1/8-inch-wide; a filled crack can be of any width, but its filler material must be in satisfactory condition.</p> <p><u>Medium</u> One of the following conditions exists: (1) a filled or non-filled crack is moderately spalled (some FOD potential); (2) a non-filled crack has a mean width between 1/8 inch and 1 inch; (3) a filled crack has no spalling or minor spalling, but the filler is in unsatisfactory condition; or (4) the slab is divided into three pieces by two or more cracks.</p> <p><u>High</u> One of the following conditions exists: (1) a filled or non-filled crack is severely spalled (definite FOD potential); (2) a non-filled crack has a mean width approximately greater than 1 inch, creating tire damage potential, or (3) the slab is divided into three pieces by two or more cracks, one of which is at least medium-severity.</p>	<p><u>Medium</u> Severity Crack at Taxiway S</p>

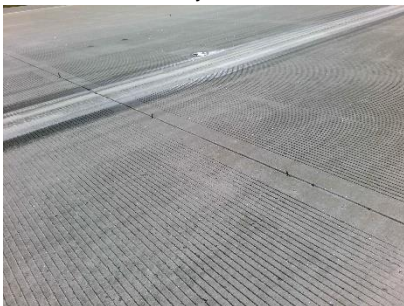
Distress Code	Description	Distress Type	Severity Levels	Sample Pictures
65	Joint Seal Damage	Other	<p><u>Low</u> Joint sealer is in generally good condition throughout the section. Sealant is performing well, with only a minor amount of any of the above types of damage present.</p> <p><u>Medium</u> Joint sealer is in generally fair condition over the entire surveyed section, with one or more of the above types of damage occurring to a moderate degree. Sealant needs replacement within 2 years.</p> <p><u>High</u> Joint sealer is in generally poor condition over the entire surveyed section, with one or more of the above types of damage occurring to a severe degree. Sealant needs immediate replacement.</p>	<p><u>High</u> Severity Joint Seal Damage at Runway 8L/26R</p>

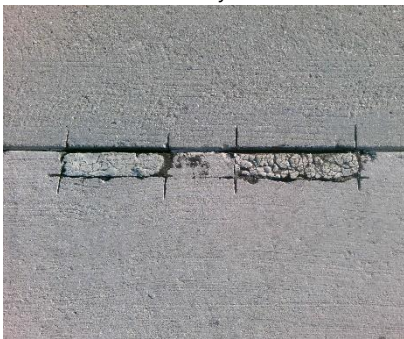
66	Patching, Small	Other	<p><u>Low</u> Patch is functioning well, with little or no deterioration.</p> <p><u>Medium</u> Patch has deteriorated, and/or moderate spalling can be seen around the edges. Patch material can be dislodged, with considerable effort (minor FOD potential).</p> <p><u>High</u> Patch has deteriorated, either by spalling around the patch or cracking within the patch, to a state which warrants replacement.</p>	<p><u>Medium</u> Severity Small Patching at Taxiway W</p>

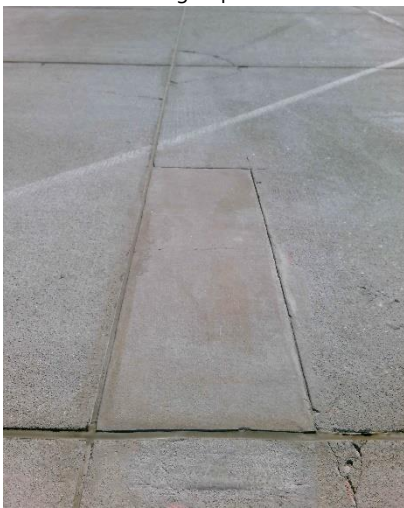
67	Patching, Large	Other	<p><u>Low</u> Patch is functioning well, with little or no deterioration.</p> <p><u>Medium</u> Patch has deteriorated, and/or moderate spalling can be seen around the edges. Patch material can be dislodged with considerable effort, causing some FOD potential.</p> <p><u>High</u> Patch has deteriorated to a state which causes considerable roughness and/or high FOD potential. The extent of the deterioration warrants replacement of the patch.</p>	<p><u>Low</u> Severity Large Patching at South Cargo Apron</p>

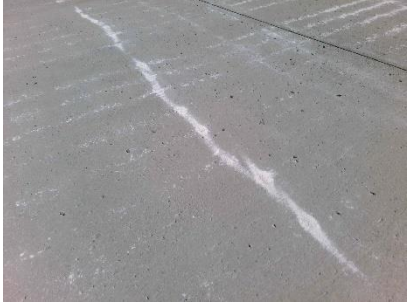
Distress Code	Description	Distress Type	Severity Levels	Sample Pictures
68	Popouts	Climate/Other	No degrees of severity are defined for popouts. However, popouts must be extensive before they are counted as a distress; i.e., average popout density must exceed approximately three popouts per square yard over the entire slab area.	<p>Popouts at Taxilane N1</p>

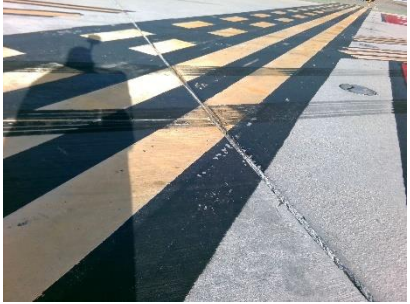
Distress Code	Description	Distress Type	Severity Levels	Sample Pictures
71	Settlement or Faulting	Load	<p><u>Low</u> < 1/4 inch for runways/taxiways and 1/8 – 1/2 inch for aprons.</p> <p><u>Medium</u> 1/4 – 1/2 inch for runways/taxiways and 1/2 - 1 inch for aprons.</p> <p><u>High</u> > 1/2 inch for runways/taxiways and > 1 inch for aprons.</p>	<p><u>Low</u> Severity Settlement at Taxiway K</p>

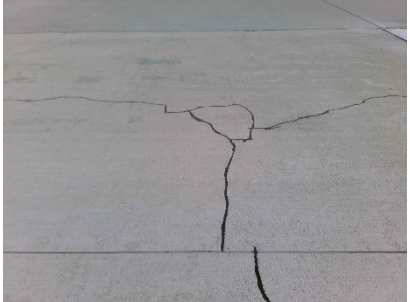
72	Shattered Slab	Load	<p><u>Low</u> Slab is broken into four or five pieces with the vast majority of the cracks (over 85 percent) of low-severity.</p> <p><u>Medium</u> (1) Slab is broken into four or five pieces with over 15 percent of the cracks of medium-severity (no high-severity cracks); or (2) slab is broken into six or more pieces with over 85 percent of the cracks of low-severity.</p> <p><u>High</u> At this level of severity, the slab is called shattered: (1) slab is broken into four or five pieces with some or all of the cracks of high-severity; (2) slab is broken into six or more pieces with over 15 percent of the cracks of medium- or high-severity.</p>	<p><u>Low</u> Severity Shattered Slab at Taxiway S</p>

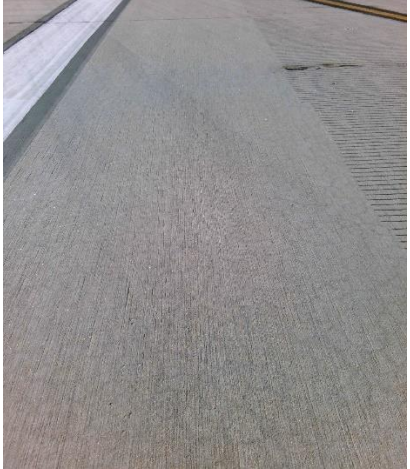
73	Shrinkage Cracking	Other	<p>No degrees of severity are defined. It is sufficient to indicate that shrinkage cracks exist.</p>	<p>Shrinkage Cracking at Runway 8R/26L</p>

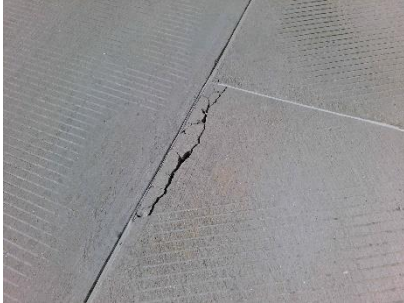
Distress Code	Description	Distress Type	Severity Levels	Sample Pictures
74	Spalling (Joint)	Load/ Other	<p><u>Low</u> For a spall length of <2 ft.; spall is broken into pieces or fragmented; little FOD or tire damage potential exists.</p> <p>For a spall length of >2 ft.; (a) spall is broken into no more than three pieces defined by low- or medium-severity cracks; little or no FOD potential exists; or (b) joint is lightly frayed; little or no FOD potential exists.</p> <p><u>Medium</u> For a spall length of <2 ft.; spall is broken into pieces or fragmented, with some of the pieces loose or absent, causing considerable FOD or tire damage potential.</p> <p>For a spall length of >2 ft.; (a) spall is broken into more than three pieces defined by light or medium cracks; (b) spall is broken into no more than three pieces with one or more of the cracks being severe with some FOD potential existing; or (c) joint is moderately frayed, with some FOD potential.</p> <p><u>High</u> For a spall length of <2 ft.; the joint is lightly frayed, the spall should not be counted.</p> <p>For a spall length of >2 ft.; (1) spall is broken into more than three pieces defined by one or more high-severity cracks with high FOD potential; or (2) joint is severely frayed, with high FOD potential.</p>	<p><u>Medium</u> Severity Joint Spall at Taxiway R</p>

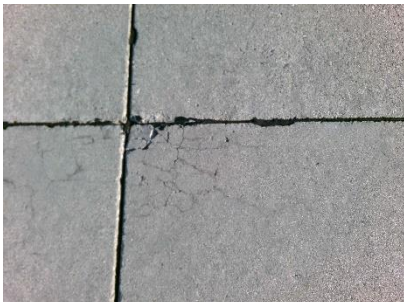
75	Spalling (Corner)	Load/ Other	<p><u>Low</u> One of the following conditions exists: (1) spall is broken into one or two pieces defined by low-severity cracks (little or no FOD potential), (2) spall is defined by one medium-severity crack (little or no FOD potential).</p> <p><u>Medium</u> One of the following conditions exists: (1) spall is broken into two or more pieces defined by medium-severity crack(s), and a few small fragments may be absent or loose; (2) spall is defined by one severe, fragmented crack that may be accompanied by a few hairline cracks;</p>	<p><u>Medium</u> Severity Corner Spall at Taxiway W</p>

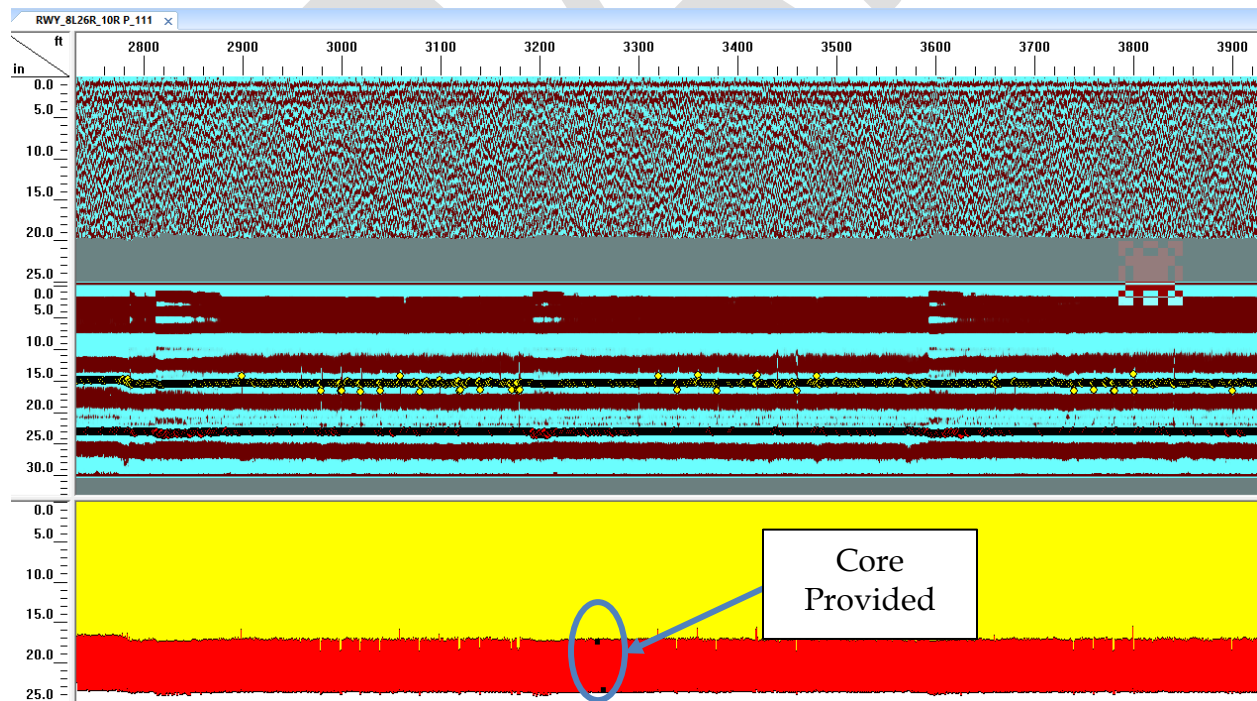
Figure 1. PCC and CTB Layer Thickness for Runway 8L/26R 10R Obtained from GPR

A total of 10 pavement cores and 6 geotechnical borings in addition to the preliminary as-built data were collected and used to perform the GPR data analysis. Figure 1 shows a GPR post-processed plot for a section of Runway 8L/26R 10R showing the interface between the Portland Cement Concrete (PCC) layer, the Cement Treated Base (CTB) layer, and the subgrade layer; and the corresponding core data used for calibration/verification. It is important to note that while pavement cores are at discrete locations, the GPR measurements were done continuously along the same HWD test lines so that each tested location would have a corresponding unique pavement structure. Table 4 shows the pavement layer information used in the analyses.

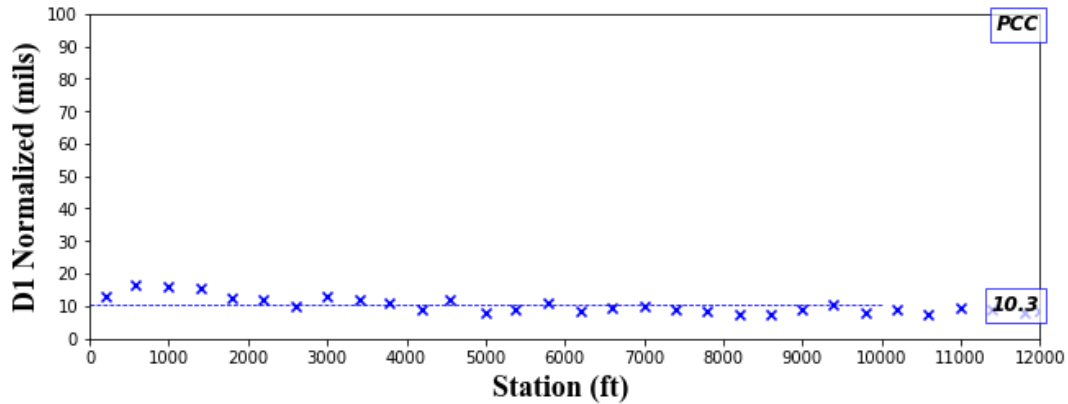
Figure 3 - Normalized Center Deflections for Runway 8L/26R

From the statistical analysis shown in Table 8, it is clear that all of the PCC sections at ONT show the average normalized center deflections less than 20 mils. However, there are some sections that show overall higher average normalized center deflections (>50mils). This is evident specifically for all asphalt pavements including Aprons and Taxiway H.

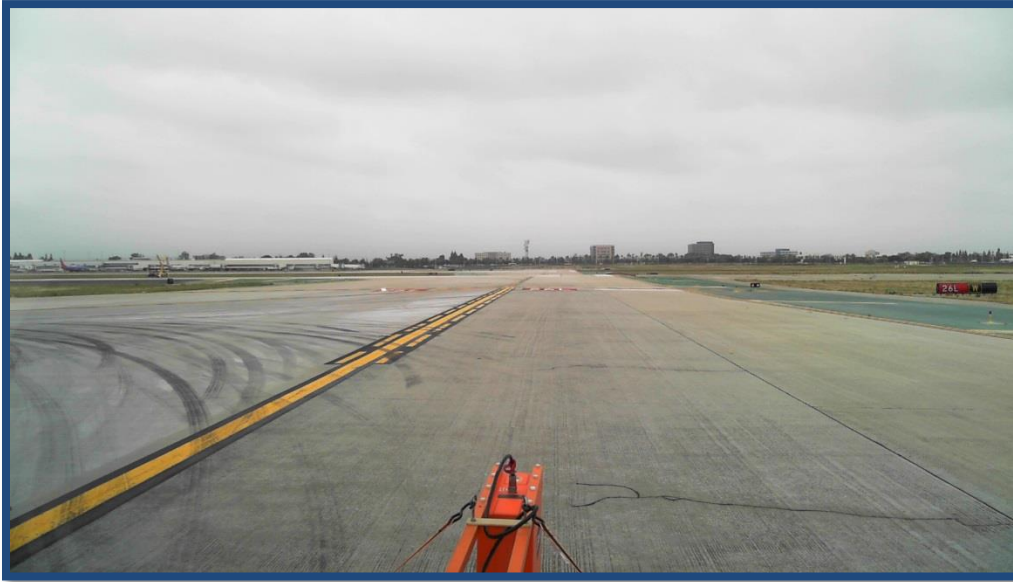
Figure F.28. Taxiway W Representative Pavement Condition (Sta. 4+05)

From Sta. 0+00 to Sta. 3+25, the PCC pavement surface appears to be in fairly good condition with no noticeable cracks. From Sta. 3+25 to Sta. 6+50 the PCC pavement surface appears to be in fairly poor condition with transverse cracks noted. From Sta. 6+50 to Sta. 12+70, the PCC pavement surface appears to be in fairly good condition with no noticeable cracks.

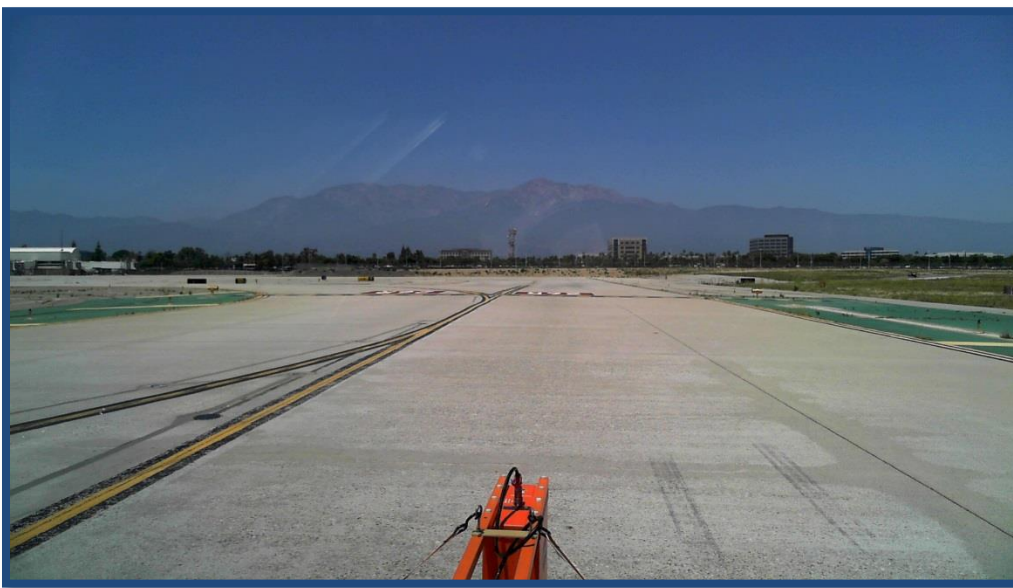
Figure F.29. Taxiway W Representative Pavement Condition (Sta. 4+50)

From Sta. 0+00 to Sta. 6+00, the PCC pavement surface appears to be in fairly poor condition with transverse cracks noted. From Sta. 6+00 to Sta. 11+00 the PCC pavement surface appears to be in fairly good condition with no noticeable cracks.

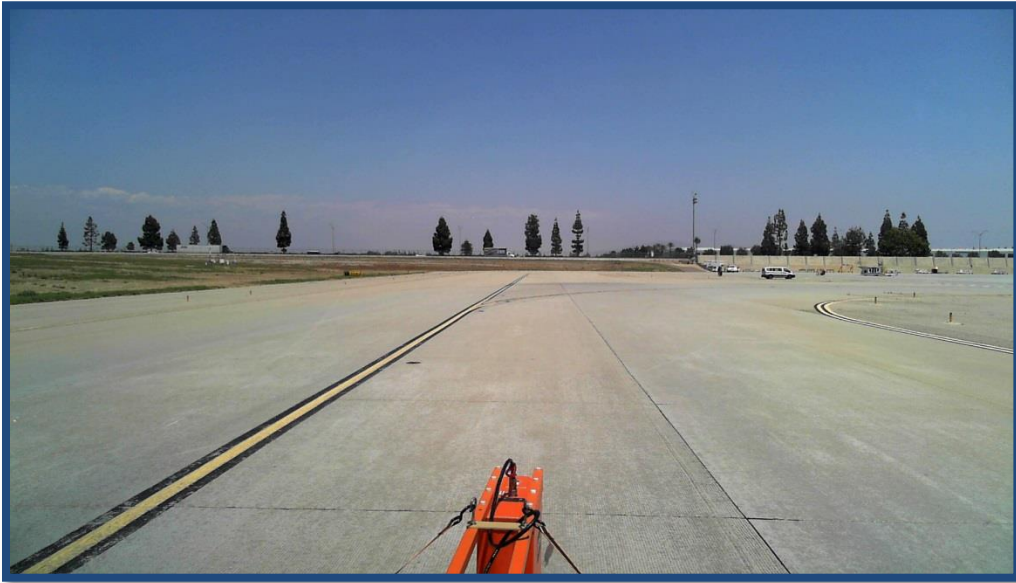
Figure F.30. Taxiway Y Representative Pavement Condition (Sta. 6+87)

From Sta. 0+00 to Sta. 16+00, the PCC pavement surface appears to be in fairly good condition with no noticeable cracks.

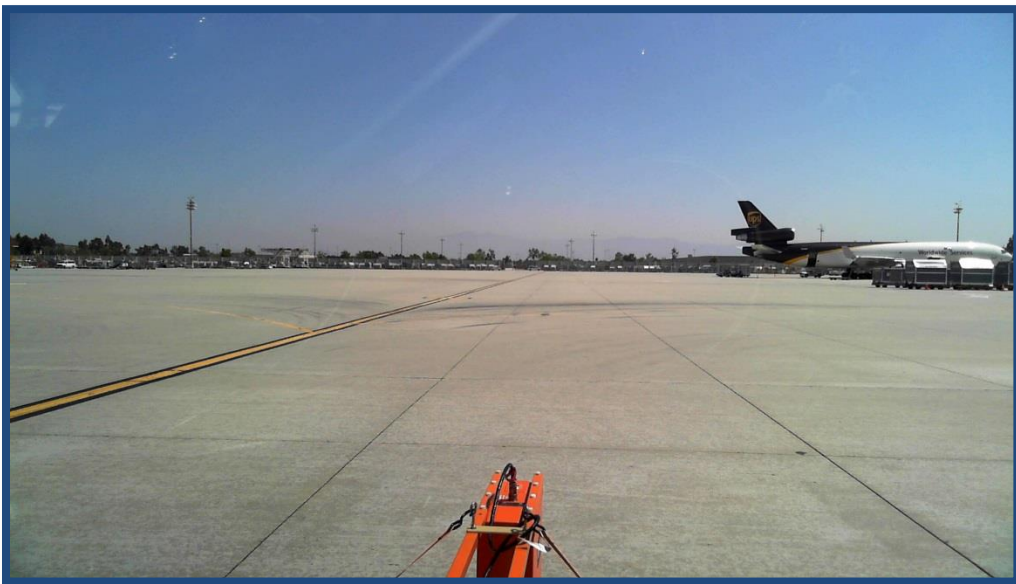
Figure F.31. Taxiway Y1 Representative Pavement Condition (Sta. 0+98)

From Sta. 0+00 to Sta. 1+65, the PCC pavement surface appears to be in fairly good condition with no noticeable cracks.

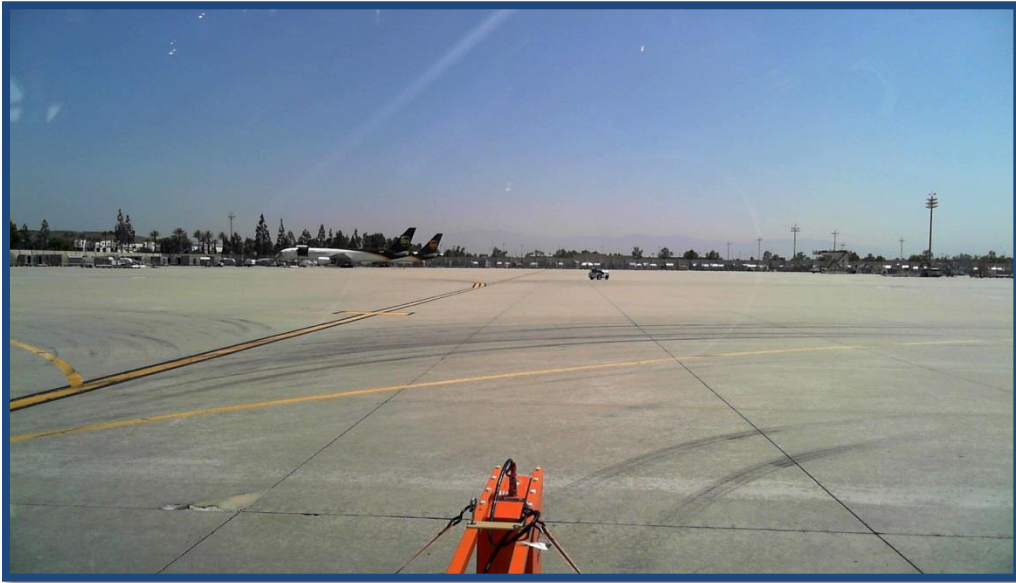
Figure F.32. Taxiway Y2 Representative Pavement Condition (Sta. 1+64)

From Sta. 0+00 to Sta. 1+65, the PCC pavement surface appears to be in fairly good condition with a localized popout noted at approximately Station 1+64.

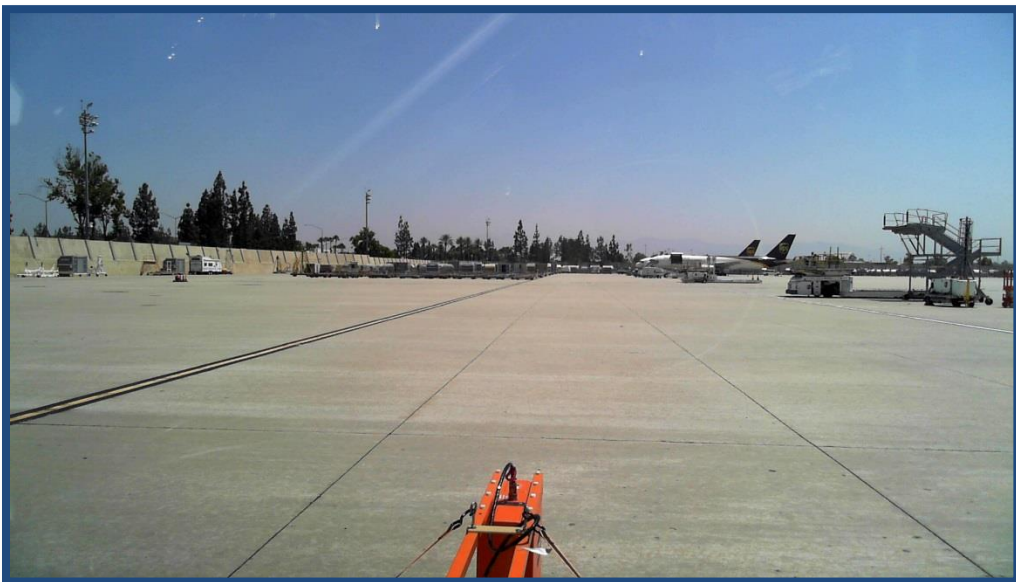
Figure F.33. Taxiway Y3 Representative Pavement Condition (Sta. 1+55)

From Sta. 0+00 to Sta. 1+65, the PCC pavement surface appears to be in fairly good condition with no noticeable cracks.

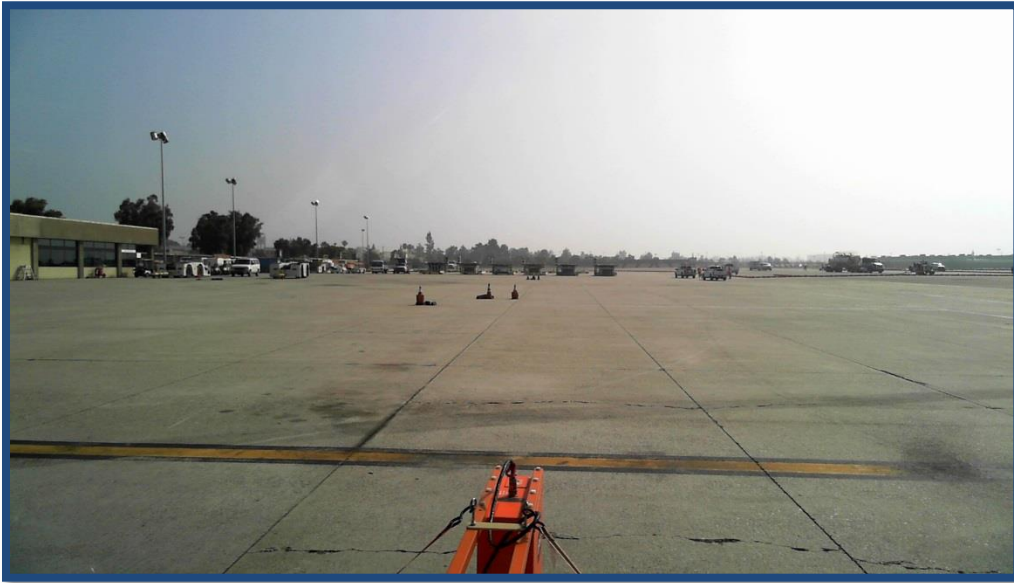
Figure F.34. Terminal 1 Apron Representative Pavement Condition (Sta. 2+08)

From Sta. 0+00 to Sta. 6+00, the PCC pavement surface appears to be in fairly poor condition with transverse cracks, longitudinal cracks, and corner breaks noted.

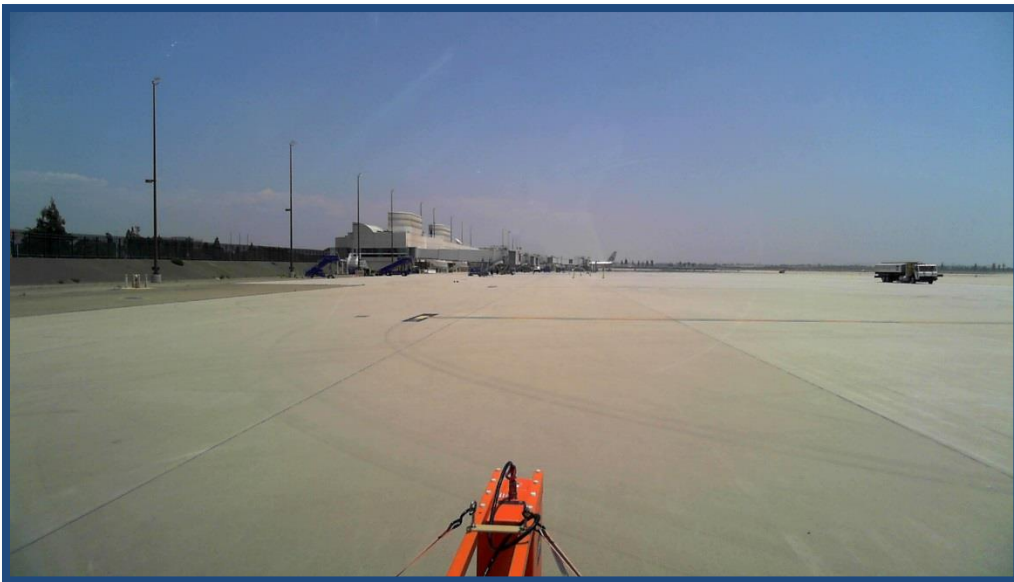
Figure F.35. Terminal 3 Apron Representative Pavement Condition (Sta. 5+50)

From Sta. 0+00 to Sta. 11+50, the PCC pavement surface appears to be in fairly good condition with no noticeable cracks.

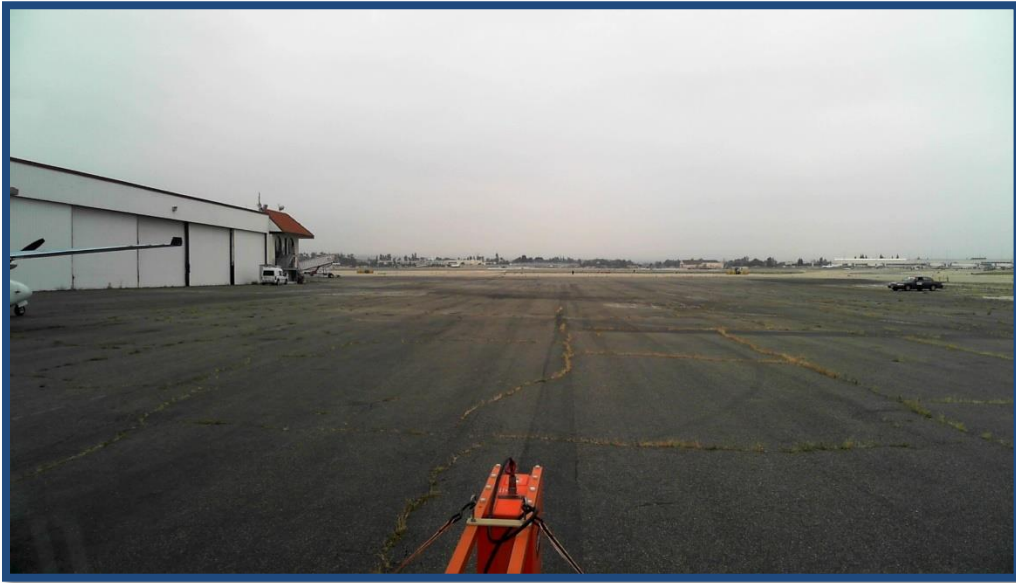
Figure F.36. Atlantic Terminal Apron Representative Pavement Condition (Sta. 3+50)

The apron is in a serious condition. From station 0+00 to station 5+00, there are high severity longitudinal and transverse cracks. At station 5+00, there are high severity alligator cracking

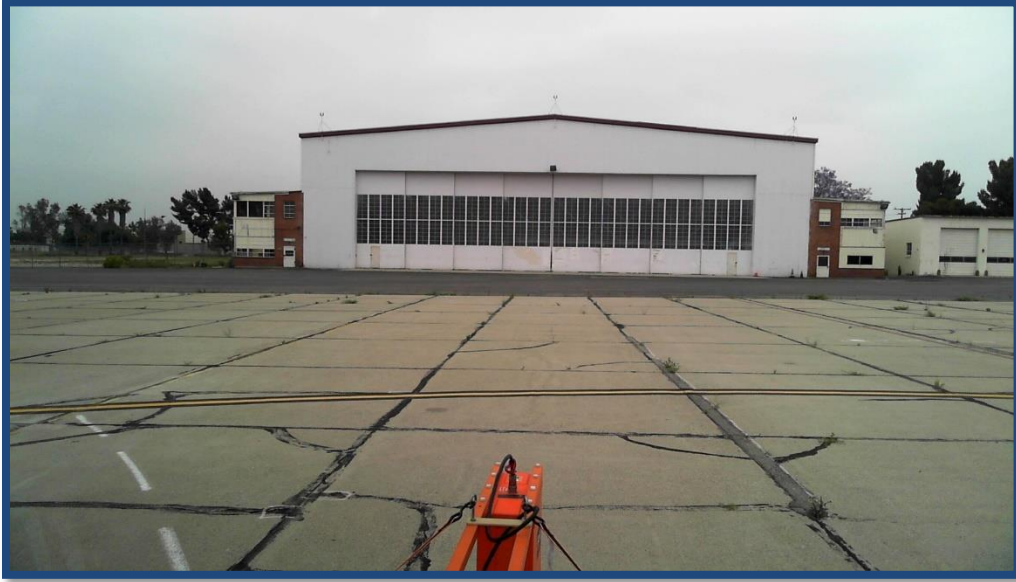
Figure F.38. CSA Terminal Representative Pavement Condition (Sta. 1+50)

The feature is in a fair condition. From station 0+00 to station to station 1+50, there are shattered slabs and severe joint seal damage and corner breaks. From station 1+50 to station 9+50, the condition is good with few medium severity corner breaks.

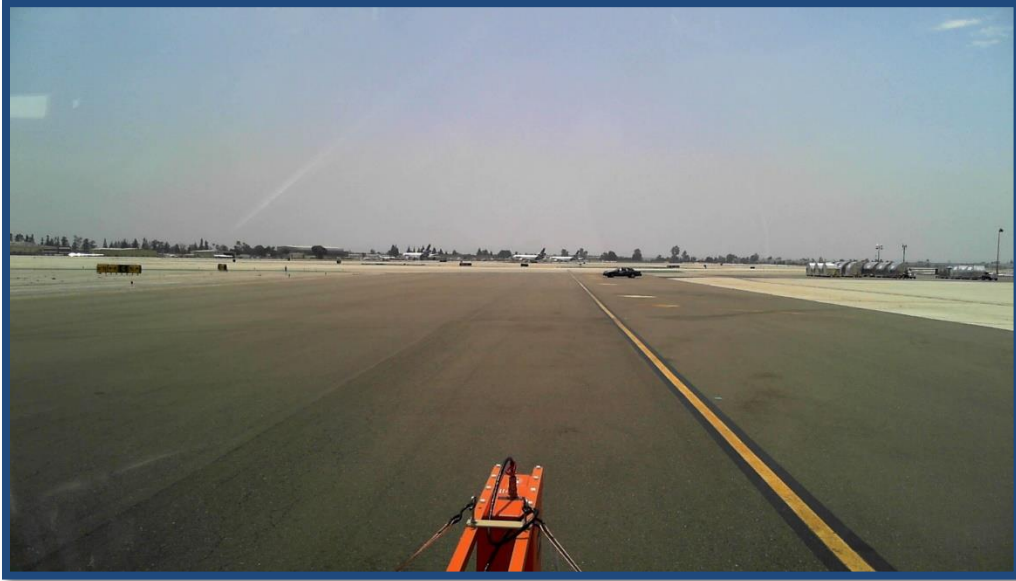
Figure F.40. Taxiway G Representative Pavement Condition (Sta. 1+75)

From Station 0+00 to station 6+00, the taxiway is in good condition with low severity alligator cracking. From station 6+00 to the end of the feature, the pavement is in bad condition with high severity fatigue and block cracks.

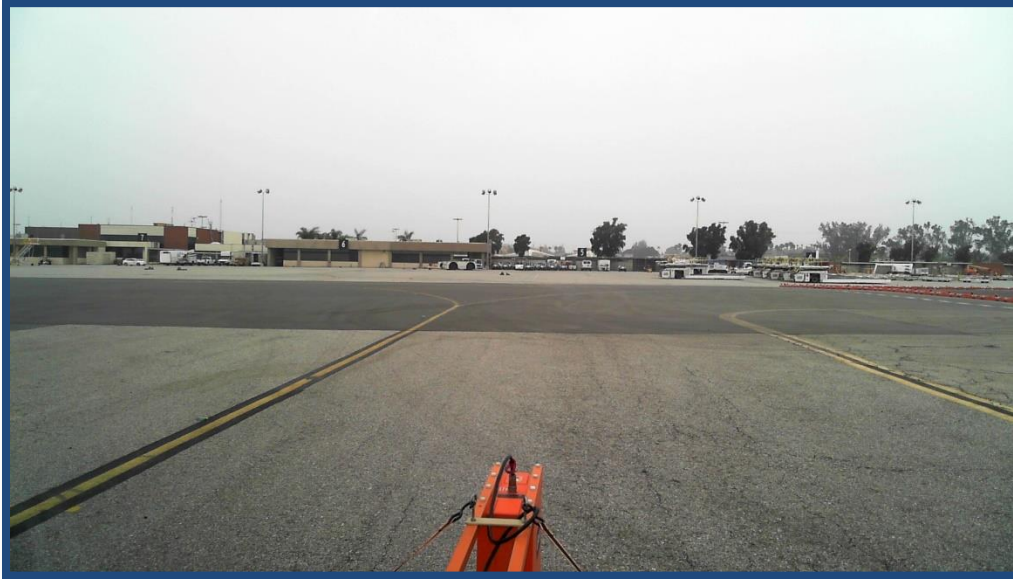
Figure F.42. Taxiway H Representative Pavement Condition (Sta. 0+00)

The feature is in a bad condition with high severity weathering, medium severity fatigue cracking, and raveling.

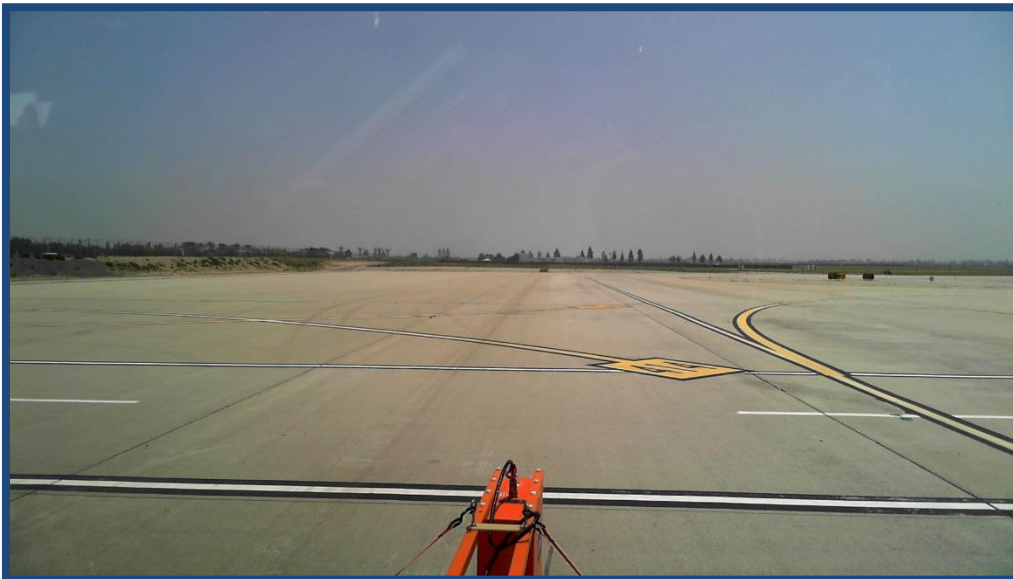
Figure F.43. Taxiway N1 Representative Pavement Condition (Sta. 48+00)

This PCC Taxiway is in a very good condition. No distresses can be observed from the ROW images.

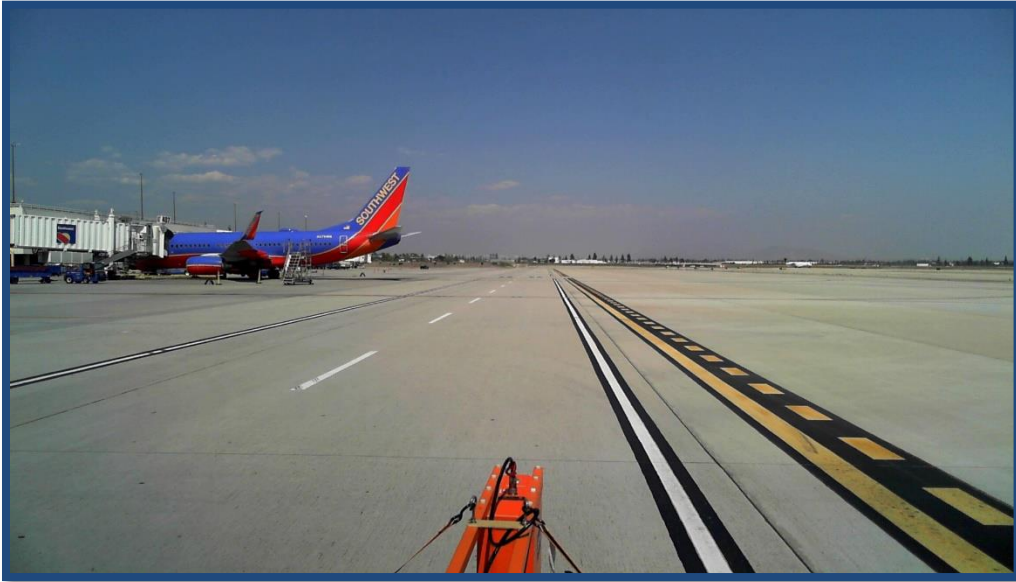
Figure F.44. Terminal2_4 Representative Pavement Condition (Sta. 36+00)

This PCC Terminal is in a very good condition. No distresses can be observed from the ROW images.
